Home Report

Single Survey

Property address	3 Main Street West Wemyss Kirkcaldy KY1 4SN
Customer	TC CAP 3 LIMITED
Customer address	3 Main Street West Wemyss Kirkcaldy KY1 4SN
Prepared by	Shepherd Chartered Surveyors
Date of inspection	13/02/2026

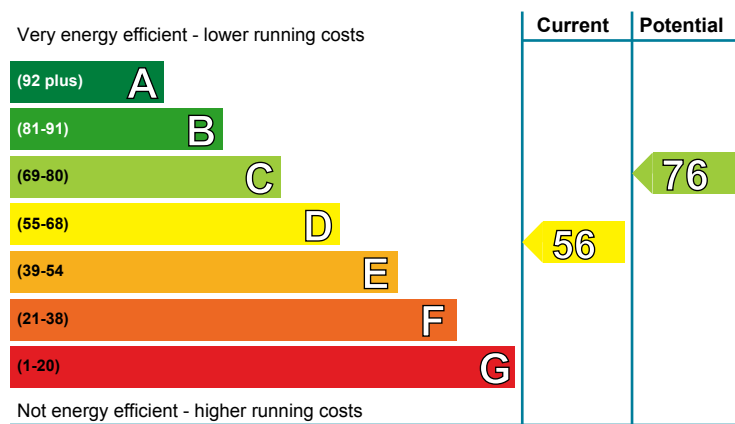
Energy Efficiency Rating

This graph shows the current efficiency of your home, taking into account both energy efficiency and fuel costs. The higher this rating, the lower your fuel bills are likely to be.

Your current rating is **band D (56)**. The average rating for EPCs in Scotland is **band D (61)**.

The potential rating shows the effect of undertaking all of the improvement measures listed within your recommendations report.

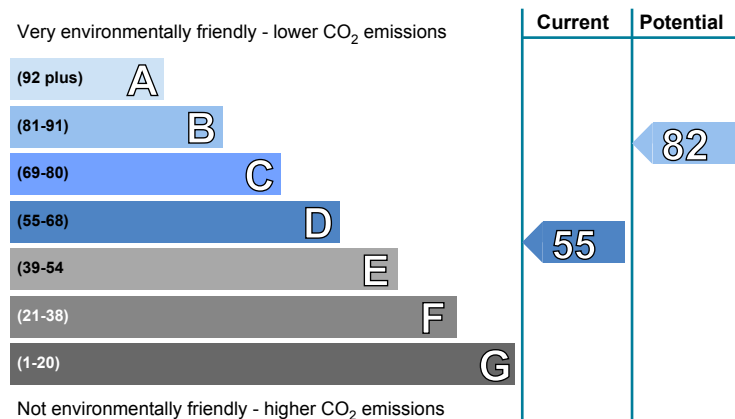
Environmental Impact (CO₂) Rating

This graph shows the effect of your home on the environment in terms of carbon dioxide (CO₂) emissions. The higher the rating, the less impact it has on the environment.
