Home Report

4 Kirkton,
Glenelg,
Kyle,
IV40 8JR

Single Survey

Property Address	4 Kirkton, Glenelg, Kyle, IV40 8JR
Reference	1484228
Customer Name	Gareth Bill
Date of Inspection	17th March 2026
Surveyor's name, qualifications and office	Colin MacGregor BSc (Hons) MRICS DM Hall LLP Chartered Surveyors Hope House, Cradlehall Business Park, Castlehill Drive Cradlehall Inverness IV2 5GH Tel: 01463 241077 email: invernessresidential@dmhall.co.uk
Prepared By	DM Hall LLP

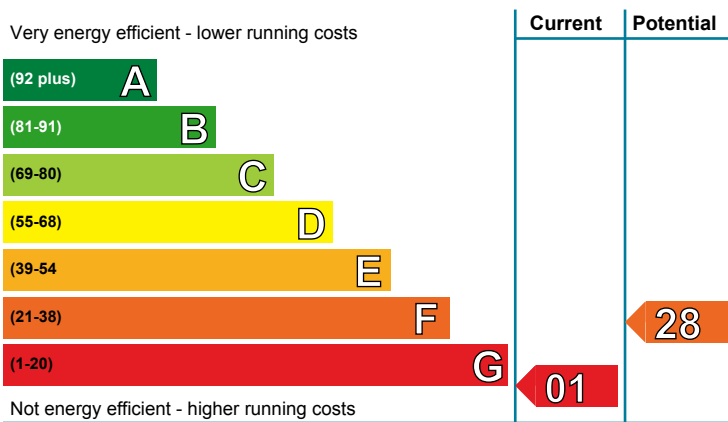
Energy Efficiency Rating

This graph shows the current efficiency of your home, taking into account both energy efficiency and fuel costs. The higher this rating, the lower your fuel bills are likely to be.

Your current rating is **band G (1)**. The average rating for EPCs in Scotland is **band D (61)**.

The potential rating shows the effect of undertaking all of the improvement measures listed within your recommendations report.

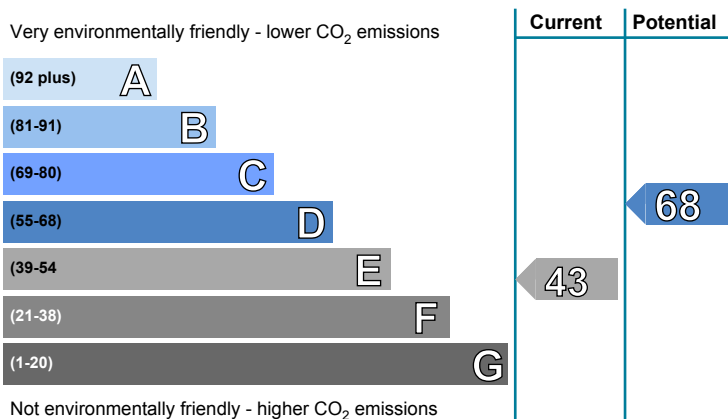
Environmental Impact (CO₂) Rating

This graph shows the effect of your home on the environment in terms of carbon dioxide (CO₂) emissions. The higher the rating, the less impact it has on the environment.
