Home Report

Single Survey

Property address	116 Blenheim Avenue East Kilbride Glasgow G75 9BL
Customer	James Arnott
Customer address	116 Blenheim Avenue East Kilbride Glasgow G75 9BL
Prepared by	Shepherd Chartered Surveyors
Date of inspection	30/01/2026

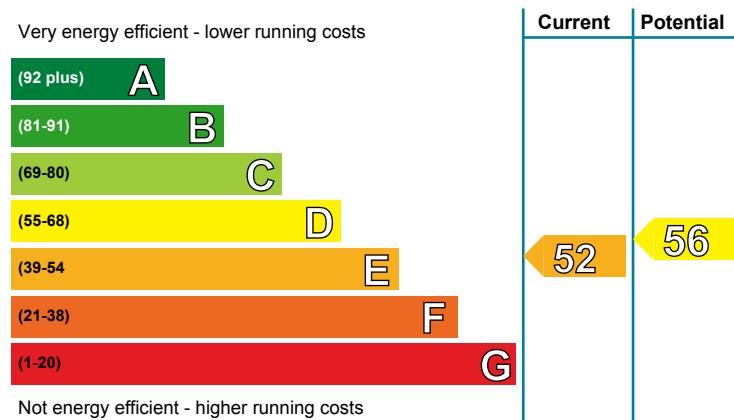
Energy Efficiency Rating

This graph shows the current efficiency of your home, taking into account both energy efficiency and fuel costs. The higher this rating, the lower your fuel bills are likely to be.

Your current rating is **band E (52)**. The average rating for EPCs in Scotland is **band D (61)**.

The potential rating shows the effect of undertaking all of the improvement measures listed within your recommendations report.

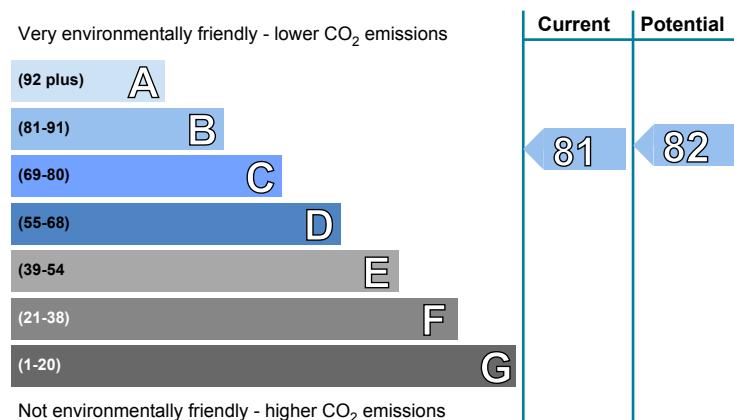
Environmental Impact (CO₂) Rating

This graph shows the effect of your home on the environment in terms of carbon dioxide (CO₂) emissions. The higher the rating, the less impact it has on the environment.
