# home report

**76 BURNSIDE ROAD  
DYCE  
ABERDEEN  
AB21 7HA**

# Energy Performance Certificate

# Single Survey

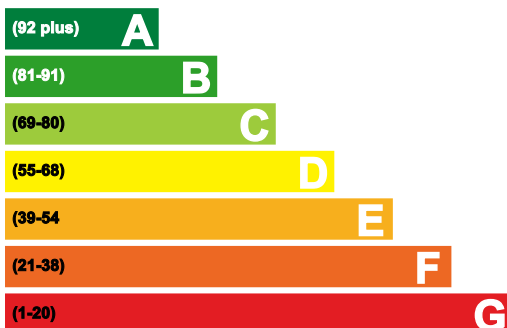
## Energy Efficiency Rating

This graph shows the current efficiency of your home, taking into account both energy efficiency and fuel costs. The higher this rating, the lower your fuel bills are likely to be.

Your current rating is **band C (77)**. The average rating for EPCs in Scotland is **band D (61)**.

The potential rating shows the effect of undertaking all of the improvement measures listed within your recommendations report.
