# Home Report

28 Pitairlie Road  
Newbigging, Broughty Ferry Dundee DD5 3RH

# Single Survey

<b>Property Address</b>	28 Pitairlie Road Newbigging, Broughty Ferry Dundee DD5 3RH
<b>Customer</b>	Angela Skelly
<b>Prepared by</b>	Graham + Sibbald Property Consultants Limited
<b>Date of Inspection</b>	27/03/2026

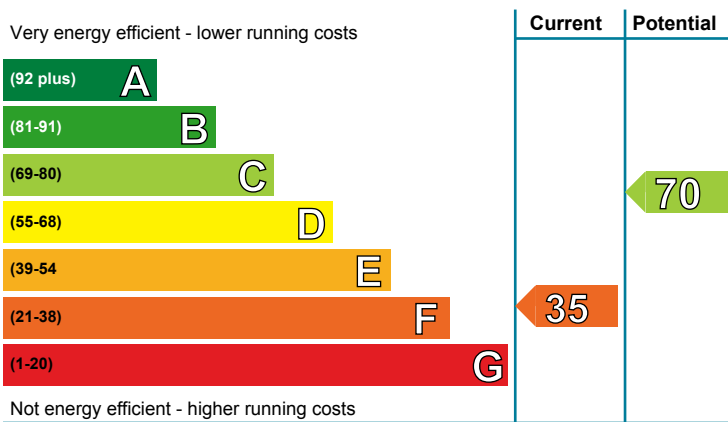
## Energy Efficiency Rating

This graph shows the current efficiency of your home, taking into account both energy efficiency and fuel costs. The higher this rating, the lower your fuel bills are likely to be.

Your current rating is **band F (35)**. The average rating for EPCs in Scotland is **band D (61)**.

The potential rating shows the effect of undertaking all of the improvement measures listed within your recommendations report.
