SINGLE SURVEY

Survey report on:

Surveyor Reference	FB/3093
Customer	Mr. Scott Meenagh
Selling address	2 Castlecary Road Cumbernauld, Glasgow G68 0HQ
Date of Re-inspection	31/03/2026
Date of Original Inspection	15/10/2025
Prepared by	Scott Livingstone, BSc (Hons) MRICS Falkirk - Allied Surveyors Scotland Ltd

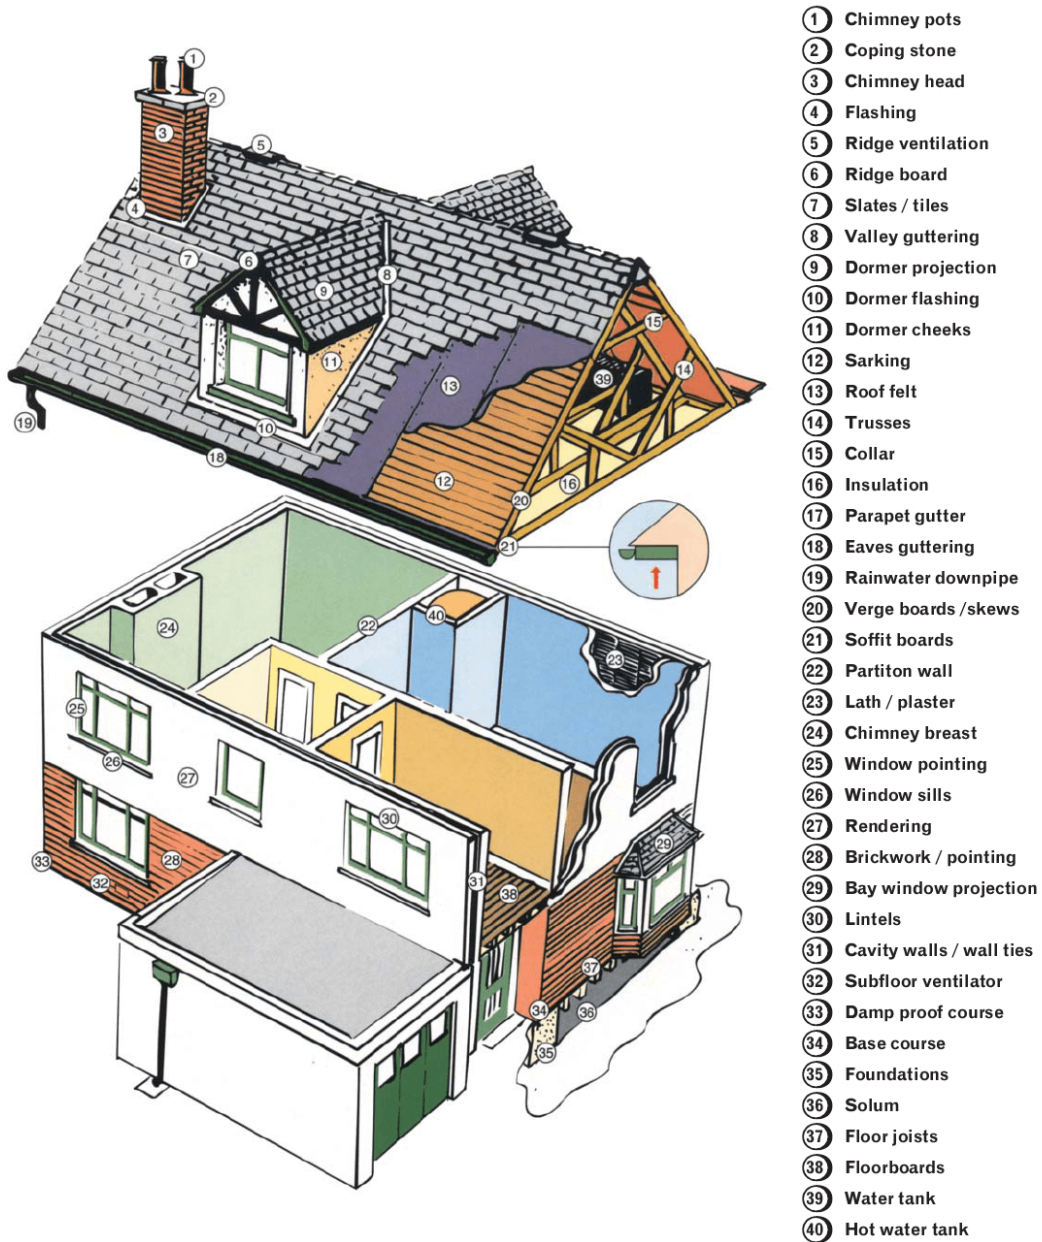
Sectional Diagram showing elements of a typical house

Reference may be made in this report to some or all of the above component parts of the property. This diagram may assist you in locating and understanding these items.
