# Home Report

# Single Survey

| <b>Property Address</b> | 73 Milton Row,<br>DENNY,<br>FK6 6NB |
| <b>Surveyor's name, qualifications and office</b> | Sean Robinson BSc (Hons) AssocRICS<br><br>DM Hall LLP Chartered Surveyors<br>Unit 6A, The Courtyard<br>Callendar Business Park<br>Falkirk<br>FK1 1XR<br><br>Tel: 01324 628321<br><br>email: centralresidential@dmhall.co.uk |

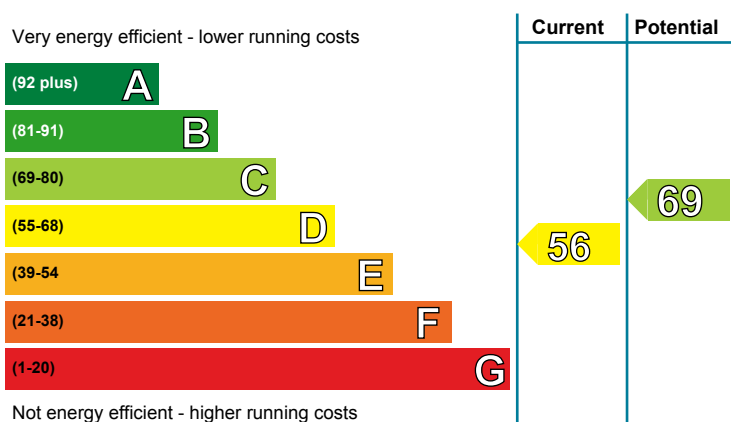
## Energy Efficiency Rating

This graph shows the current efficiency of your home, taking into account both energy efficiency and fuel costs. The higher this rating, the lower your fuel bills are likely to be.

Your current rating is **band D (56)**. The average rating for EPCs in Scotland is **band D (61)**.

The potential rating shows the effect of undertaking all of the improvement measures listed within your recommendations report.

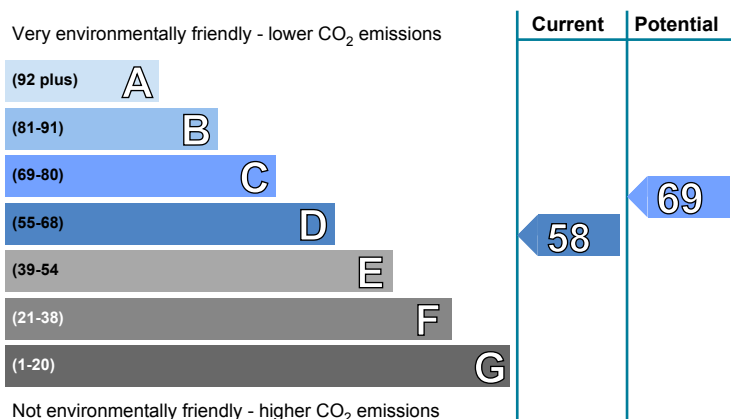
## Environmental Impact (CO<sub>2</sub>) Rating

This graph shows the effect of your home on the environment in terms of carbon dioxide (CO<sub>2</sub>) emissions. The higher the rating, the less impact it has on the environment.
