# Home Report

15 Arnott Drive,  
Coatbridge,  
Lanarkshire,  
ML5 4DL

# Single Survey

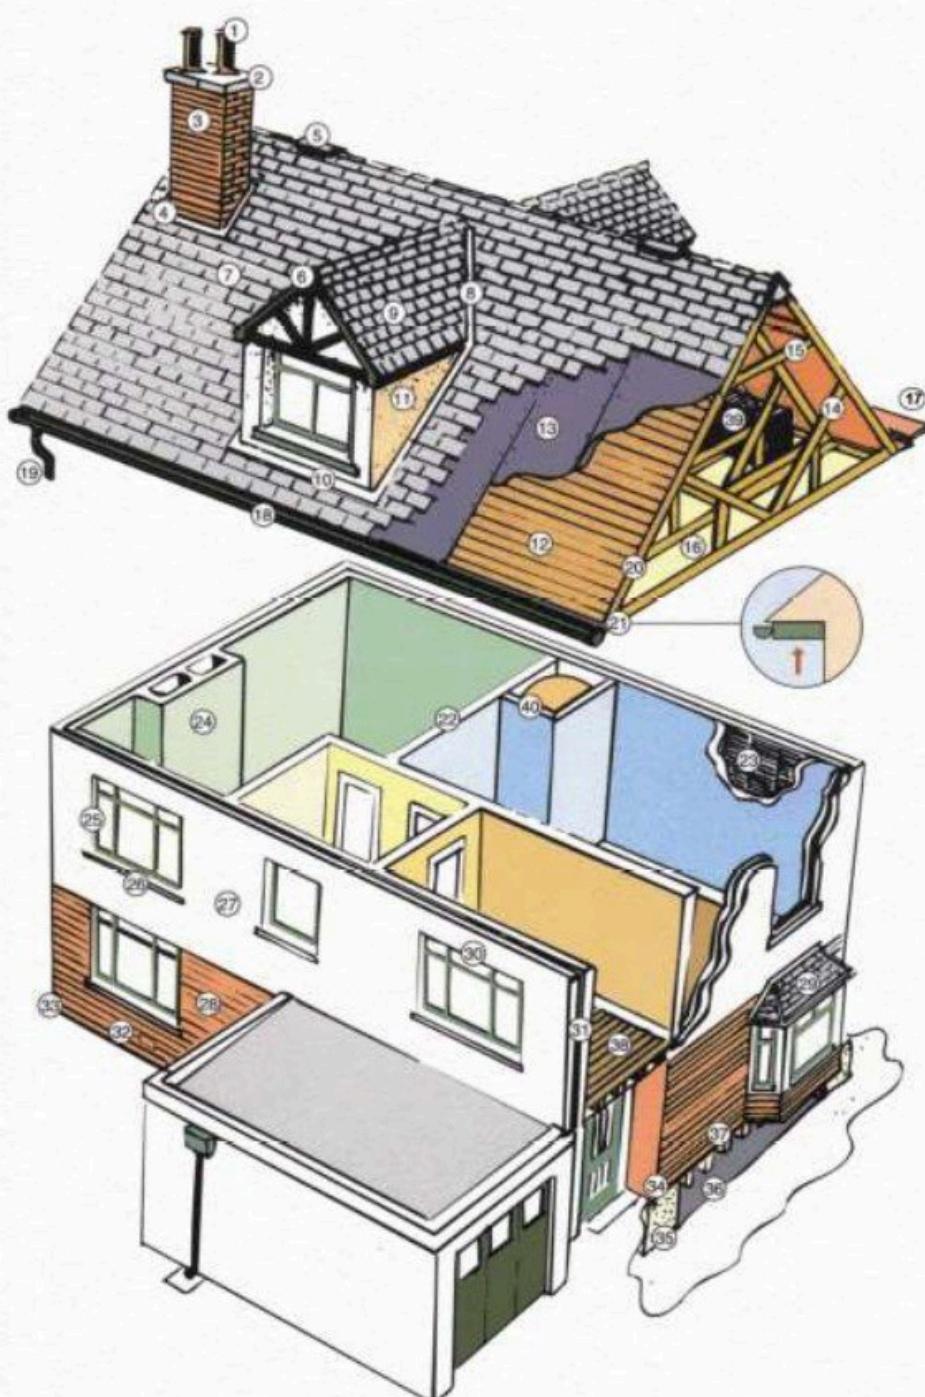
## Sectional Diagram showing elements of a typical house

- 1 Chimney pots
- 2 Coping stone
- 3 Chimney head
- 4 Flashing
- 5 Ridge ventilation
- 6 Ridge board
- 7 Slates / tiles
- 8 Valley guttering
- 9 Dormer projection
- 10 Dormer flashing
- 11 Dormer cheeks
- 12 Sarking
- 13 Roof felt
- 14 Trusses
- 15 Collar
- 16 Insulation
- 17 Parapet gutter
- 18 Eaves guttering
- 19 Rainwater downpipe
- 20 Verge boards / skewers
- 21 Soffit boards
- 22 Partition wall
- 23 Lath / plaster
- 24 Chimney breast
- 25 Window pointing
- 26 Window sills
- 27 Rendering
- 28 Brickwork / pointing
- 29 Bay window projection
- 30 Lintels
- 31 Cavity walls / wall ties
- 32 Subfloor ventilator
- 33 Damp proof course
- 34 Base course
- 35 Foundations
- 36 Solum
- 37 Floor joists
- 38 Floorboards
- 39 Water tank
- 40 Hot water tank

Reference may be made in this report to some or all of the above component parts of the property. This diagram may assist you in locating and understanding these items.
