# Home Report

2/L 565 Great Western Road  
Aberdeen AB10 6PA

# Single Survey

## Survey report on:

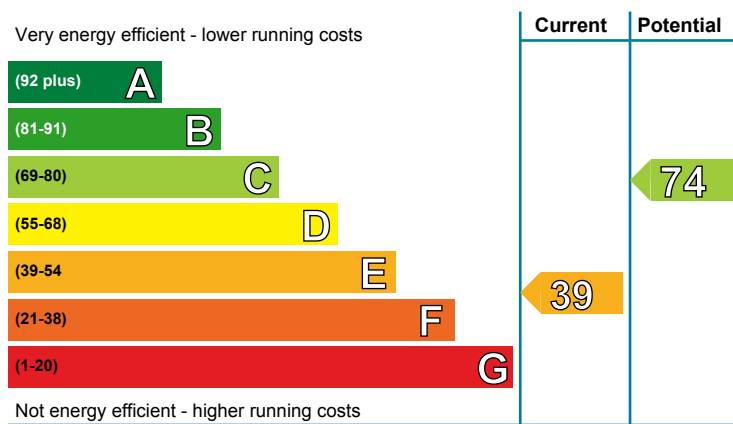
## Energy Efficiency Rating

This graph shows the current efficiency of your home, taking into account both energy efficiency and fuel costs. The higher this rating, the lower your fuel bills are likely to be.

Your current rating is **band E (39)**. The average rating for EPCs in Scotland is **band D (61)**.

The potential rating shows the effect of undertaking all of the improvement measures listed within your recommendations report.

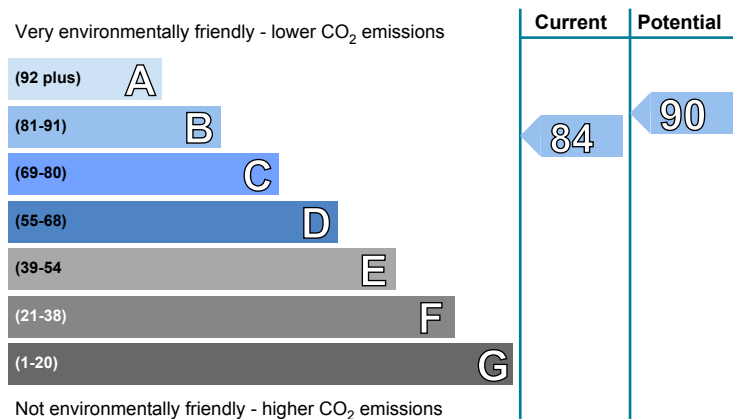
## Environmental Impact (CO<sub>2</sub>) Rating

This graph shows the effect of your home on the environment in terms of carbon dioxide (CO<sub>2</sub>) emissions. The higher the rating, the less impact it has on the environment.
