Flat 1,
22,
Kirk Wynd,
FALKIRK,
FK1 1JR

Home Report

Single Survey

Property Address	Flat 1, 22, Kirk Wynd, FALKIRK, FK1 1JR
Reference	1581478
Customer Name	Garry Fleming
Date of Inspection	14th May 2026
Surveyor's name, qualifications and office	David Telford DM Hall LLP Chartered Surveyors Unit 6A, The Courtyard Callendar Business Park Falkirk FK1 1XR Tel: 01324 628321 email: centralresidential@dmhall.co.uk
Prepared By	DM Hall LLP

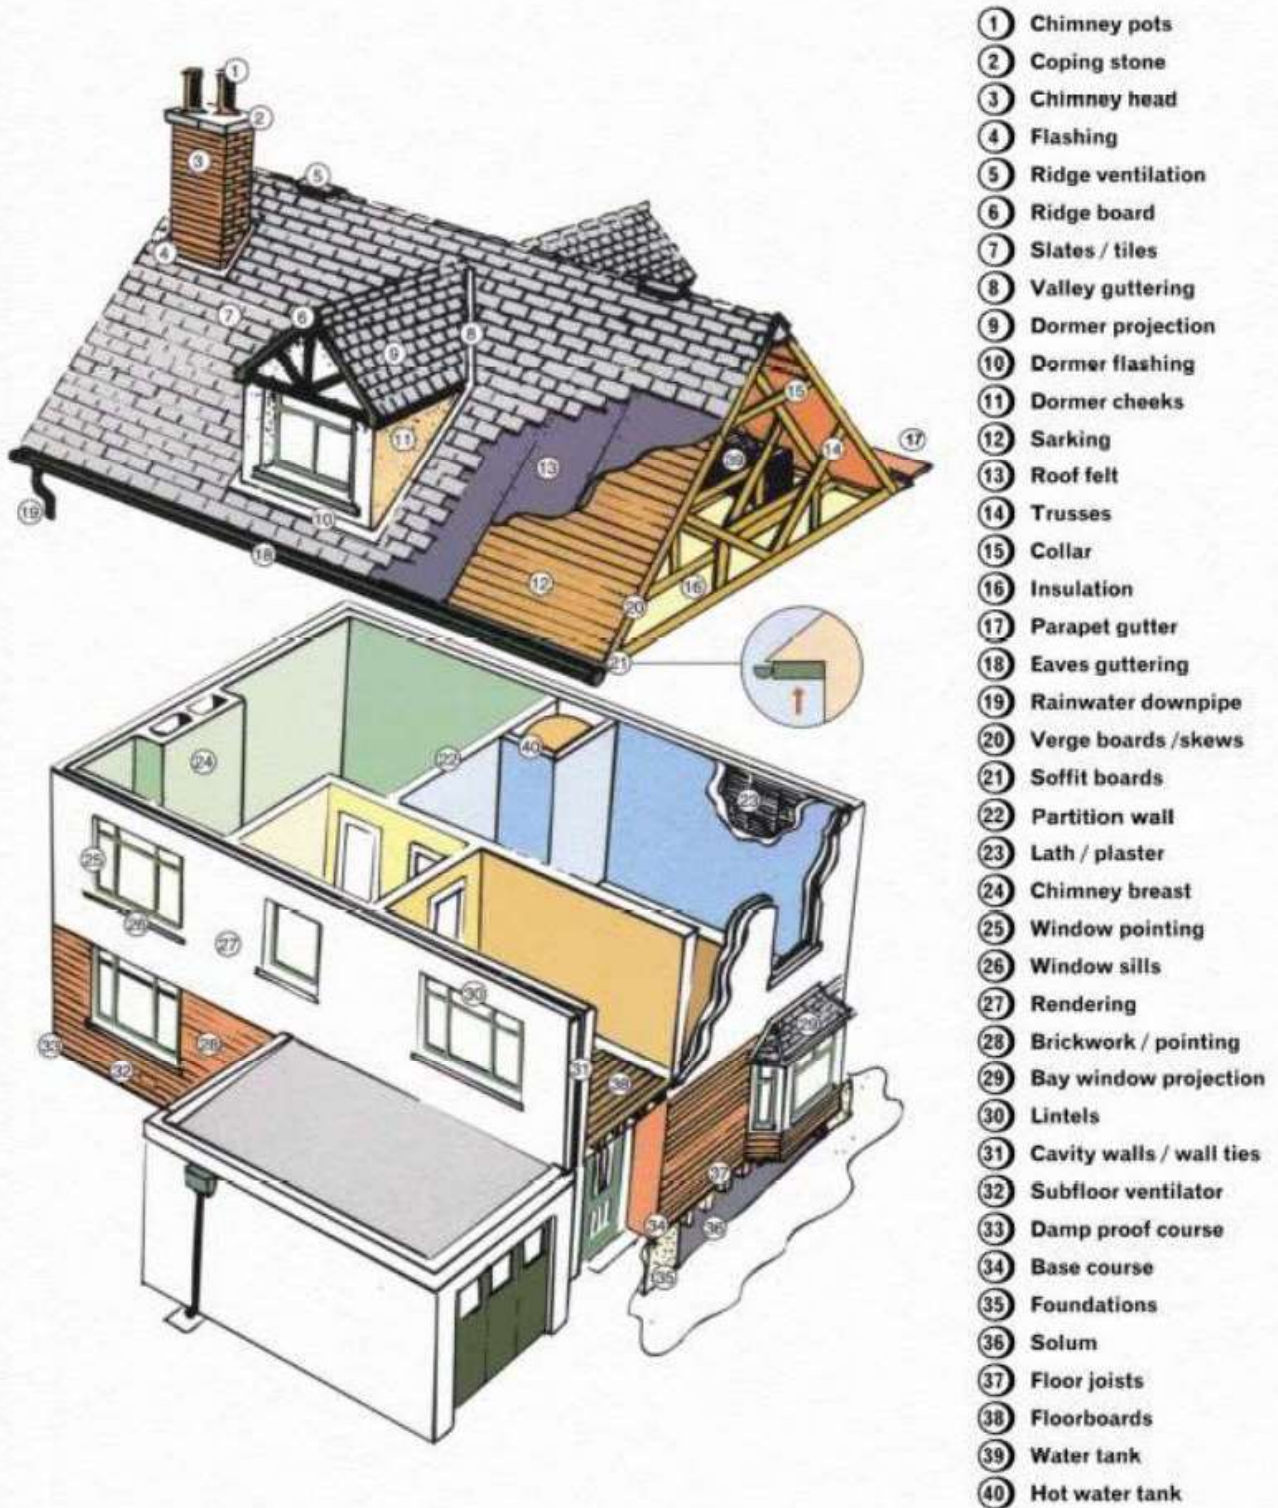
Sectional Diagram showing elements of a typical house

Reference may be made in this report to some or all of the above component parts of the property. This diagram may assist you in locating and understanding these items.
