YOUR ONESURVEY  
**HOME REPORT**

12E East High Street  
Airdrie  
ML6 6LF

# SINGLE SURVEY

# Single Survey

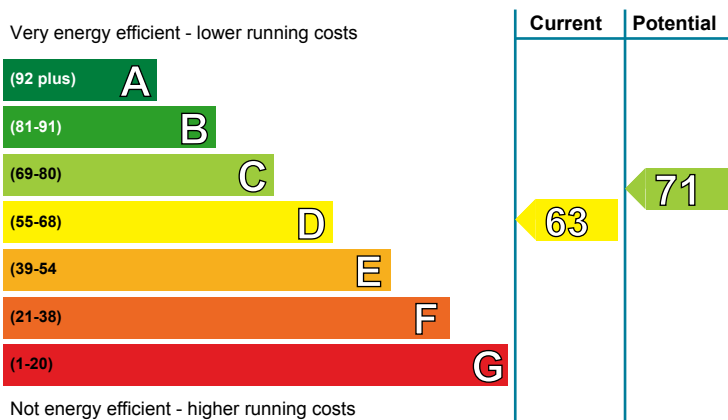
## Energy Efficiency Rating

This graph shows the current efficiency of your home, taking into account both energy efficiency and fuel costs. The higher this rating, the lower your fuel bills are likely to be.

Your current rating is **band D (63)**. The average rating for EPCs in Scotland is **band D (61)**.

The potential rating shows the effect of undertaking all of the improvement measures listed within your recommendations report.

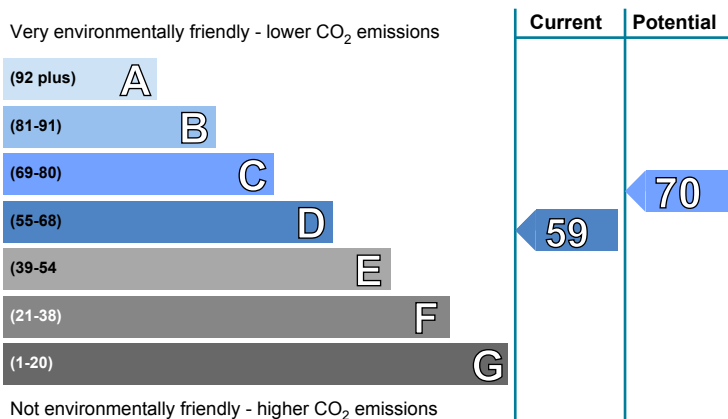
## Environmental Impact (CO<sub>2</sub>) Rating

This graph shows the effect of your home on the environment in terms of carbon dioxide (CO<sub>2</sub>) emissions. The higher the rating, the less impact it has on the environment.
