# Single Survey

| Property address | 24 MURRAY TERRACE,<br>ABERDEEN,<br>AB11 7SD |

| Prepared by | DM Hall |

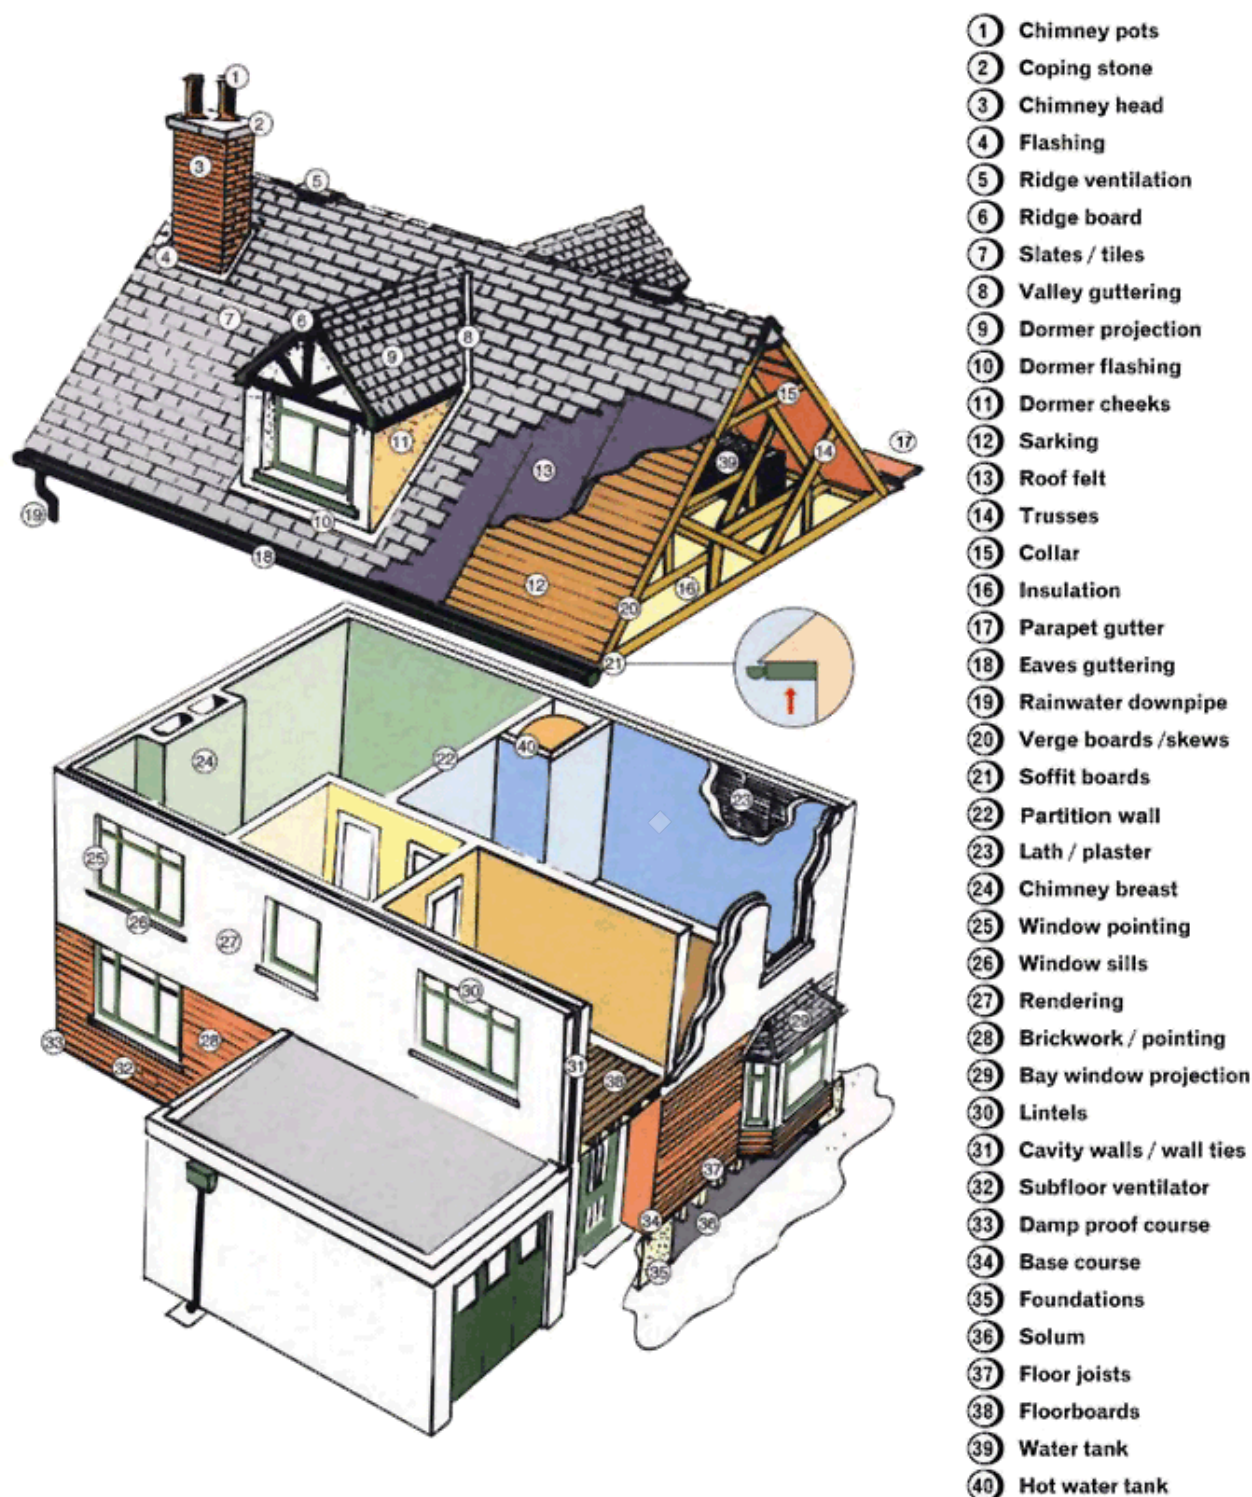
## Sectional Diagram showing elements of a typical house

Reference may be made in this report to some or all of the above component parts of the property. This diagram may assist you in locating and understanding these items.
