YOUR ONESURVEY HOME REPORT

1d James Crescent
Irvine
KA12 0UL

SINGLE SURVEY

Surveyor Reference	SA/9981
Customer	Mr. Brian Yule
Selling address	1d James Crescent Irvine KA12 0UL
Date of Inspection	30/04/2026
Prepared by	Ross Carpenter, MRICS Bsc (hons) Kilmarnock - Allied Surveyors Scotland Ltd

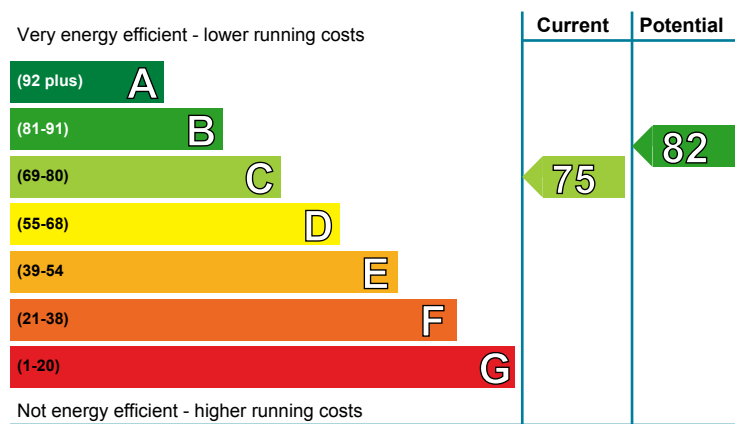
Energy Efficiency Rating

This graph shows the current efficiency of your home, taking into account both energy efficiency and fuel costs. The higher this rating, the lower your fuel bills are likely to be.

Your current rating is **band C (75)**. The average rating for EPCs in Scotland is **band D (61)**.

The potential rating shows the effect of undertaking all of the improvement measures listed within your recommendations report.

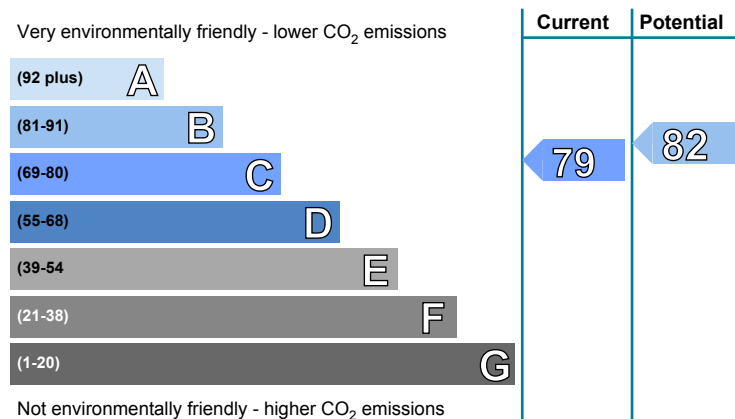
Environmental Impact (CO₂) Rating

This graph shows the effect of your home on the environment in terms of carbon dioxide (CO₂) emissions. The higher the rating, the less impact it has on the environment.
