Home Report

Scottish Single Survey

Single Survey

Property address	13 Johnstone Crescent Brora KW9 6PH
-------------------------	---

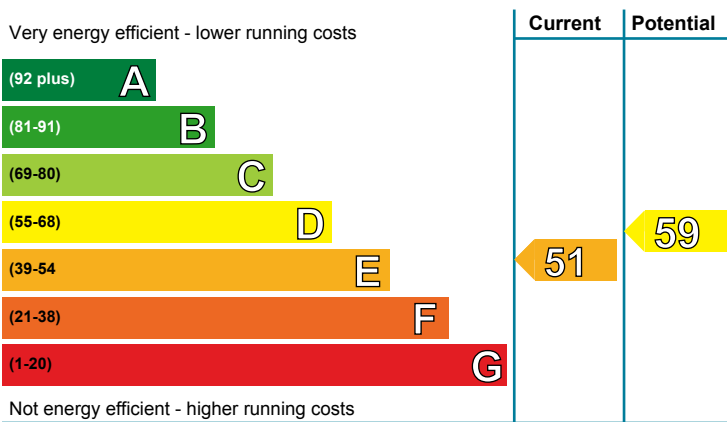
Energy Efficiency Rating

This graph shows the current efficiency of your home, taking into account both energy efficiency and fuel costs. The higher this rating, the lower your fuel bills are likely to be.

Your current rating is **band E (51)**. The average rating for EPCs in Scotland is **band D (61)**.

The potential rating shows the effect of undertaking all of the improvement measures listed within your recommendations report.

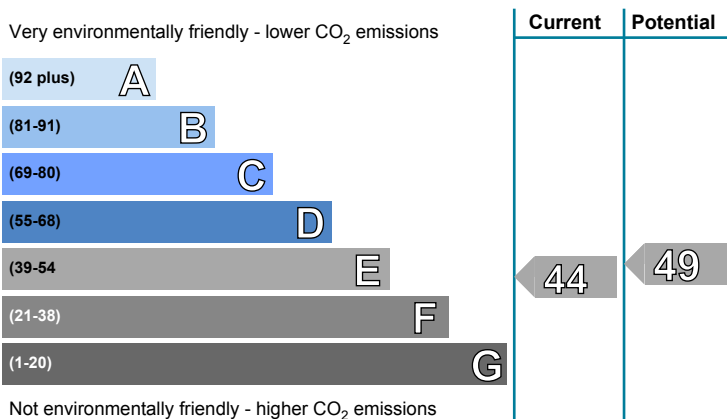
Environmental Impact (CO₂) Rating

This graph shows the effect of your home on the environment in terms of carbon dioxide (CO₂) emissions. The higher the rating, the less impact it has on the environment.
