Home Report

Single Survey

Property address	22a Rigg Street Stewarton Kilmarnock KA3 5AJ
-------------------------	---

PART 1 - GENERAL

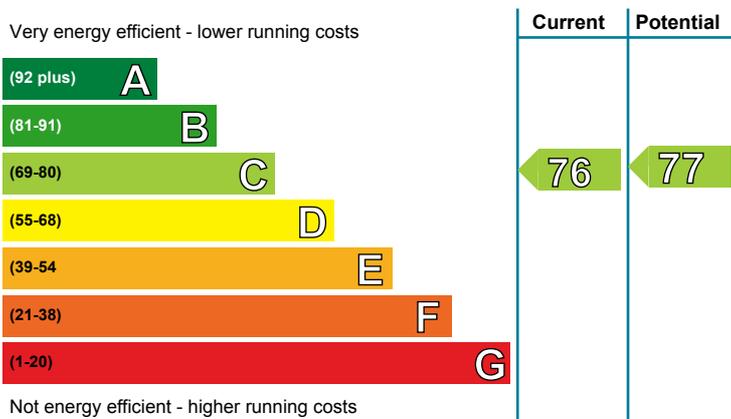
Energy Efficiency Rating

This graph shows the current efficiency of your home, taking into account both energy efficiency and fuel costs. The higher this rating, the lower your fuel bills are likely to be.

Your current rating is **band C (76)**. The average rating for EPCs in Scotland is **band D (61)**.

The potential rating shows the effect of undertaking all of the improvement measures listed within your recommendations report.

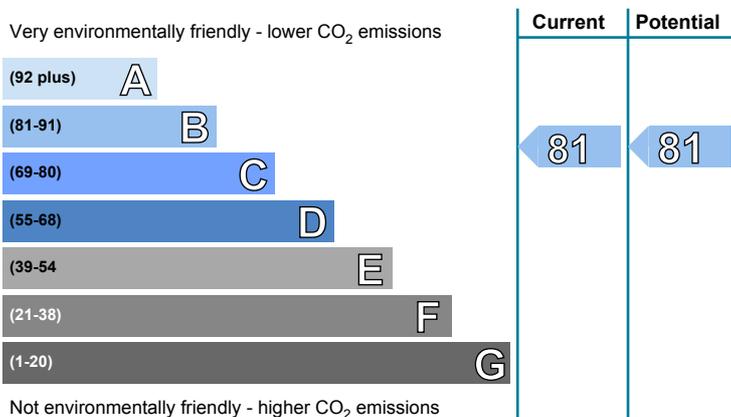
Environmental Impact (CO₂) Rating

This graph shows the effect of your home on the environment in terms of carbon dioxide (CO₂) emissions. The higher the rating, the less impact it has on the environment.
