89 Dundee Road,  
Broughty Ferry,  
Dundee,  
DD5 1LZ

# Home Report

# Single Survey

## Survey Report on:

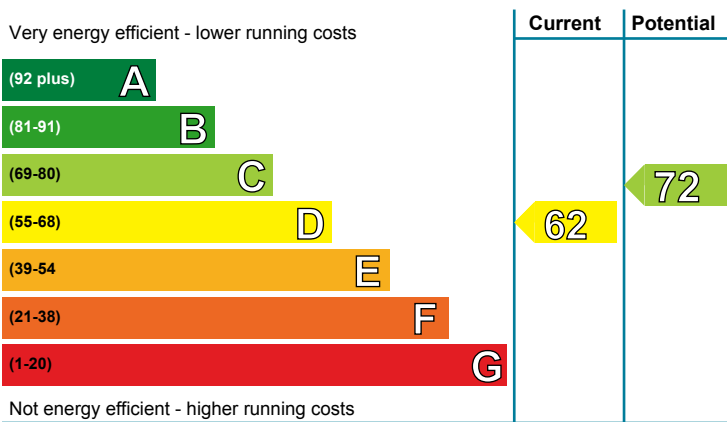
## Energy Efficiency Rating

This graph shows the current efficiency of your home, taking into account both energy efficiency and fuel costs. The higher this rating, the lower your fuel bills are likely to be.

Your current rating is **band D (62)**. The average rating for EPCs in Scotland is **band D (61)**.

The potential rating shows the effect of undertaking all of the improvement measures listed within your recommendations report.

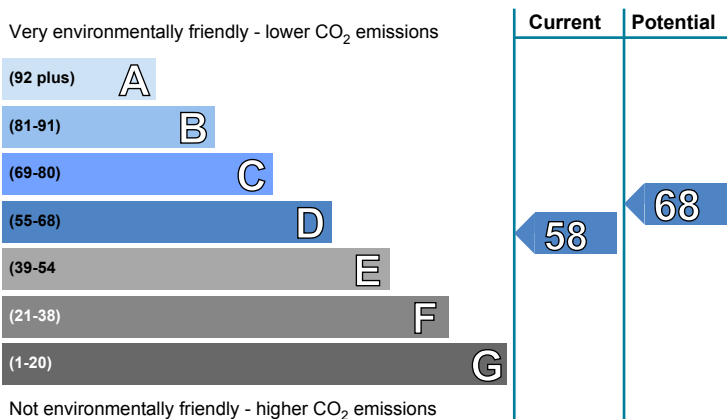
## Environmental Impact (CO<sub>2</sub>) Rating

This graph shows the effect of your home on the environment in terms of carbon dioxide (CO<sub>2</sub>) emissions. The higher the rating, the less impact it has on the environment.
