Home Report

Single Survey

Property address	36 School Wynd East Wemyss Kirkcaldy KY1 4RN
Customer	[REDACTED]
Customer address	36 School Wynd East Wemyss Kirkcaldy KY1 4RN
Prepared by	Shepherd Chartered Surveyors
Date of inspection	19/02/2026

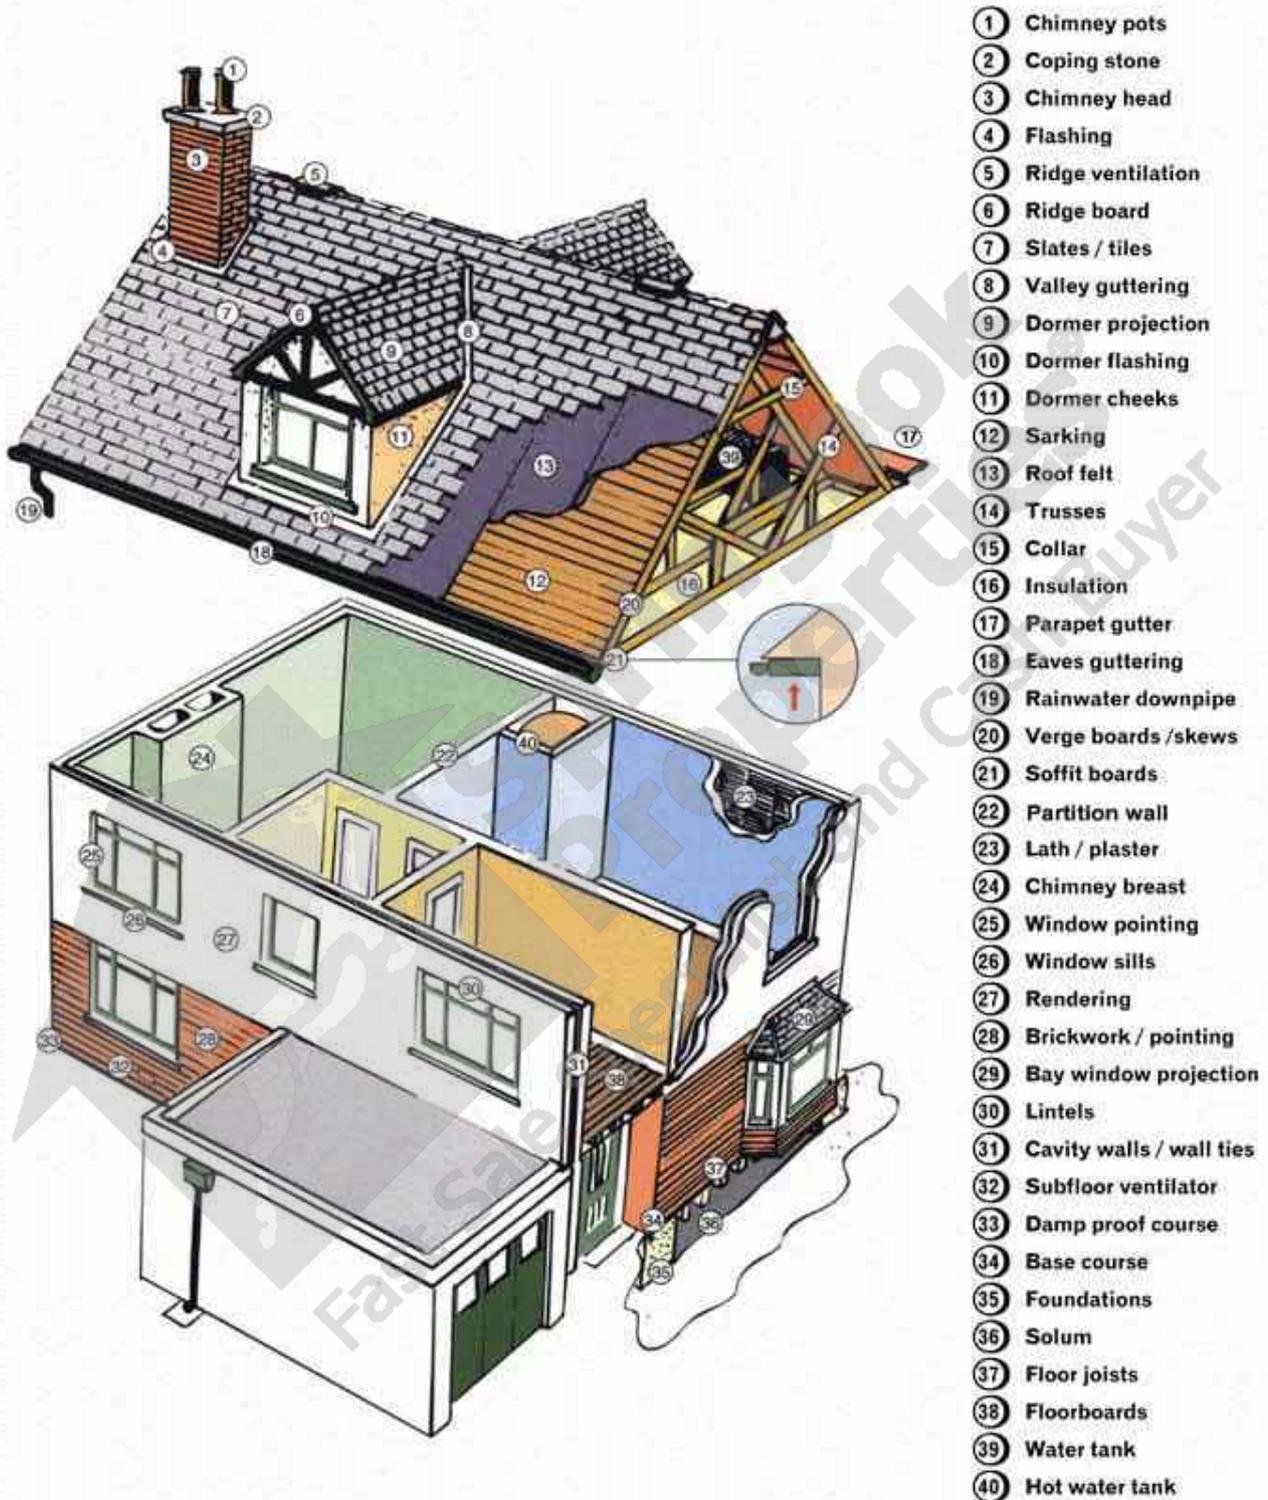
Sectional Diagram showing elements of a typical house

Reference may be made in this report to some or all of the above component parts of the property. This diagram may assist you in locating and understanding these items.
