YOUR ONESURVEY
HOME REPORT

186 Terregles Avenue
Glasgow
G41 4RR

SINGLE SURVEY

Surveyor Reference	WH/5408
Customer	Executors of Frances Howell
Selling address	186 Terregles Avenue Glasgow G41 4RR
Date of Inspection	25/02/2026
Prepared by	Greg Scrimgeour, Bsc (Hons) MRICS Glasgow South - Allied Surveyors Scotland Ltd

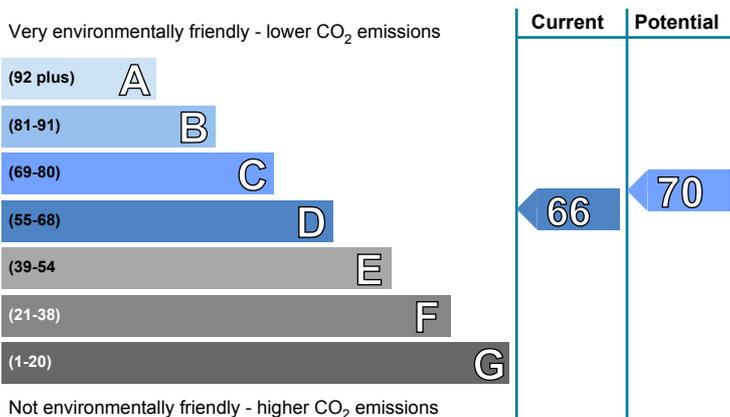
Environmental Impact (CO₂) Rating

This graph shows the effect of your home on the environment in terms of carbon dioxide (CO₂) emissions. The higher the rating, the less impact it has on the environment.
