4 Well Road,
Moffat,
DG10 9AS

Home Report

Single Survey

Property Address	4 Well Road, Moffat, DG10 9AS
Reference	1581664
Customer Name	Christian & Emma Garrick
Date of Inspection	20th May 2026
Surveyor's name, qualifications and office	Michael P Churm, BSc DM Hall LLP 11 Buccleuch Street Dumfries DG1 2AT
Prepared By	DM Hall LLP

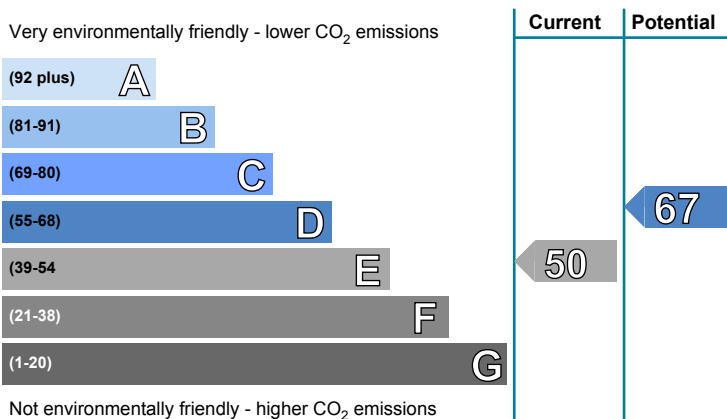
Environmental Impact (CO₂) Rating

This graph shows the effect of your home on the environment in terms of carbon dioxide (CO₂) emissions. The higher the rating, the less impact it has on the environment.
