# Home Report

5 Seymour Avenue  
Dundee DD2 1HG

# Single Survey

| <b>Description</b> | The subjects comprise a detached one and a half storey extended bungalow. |

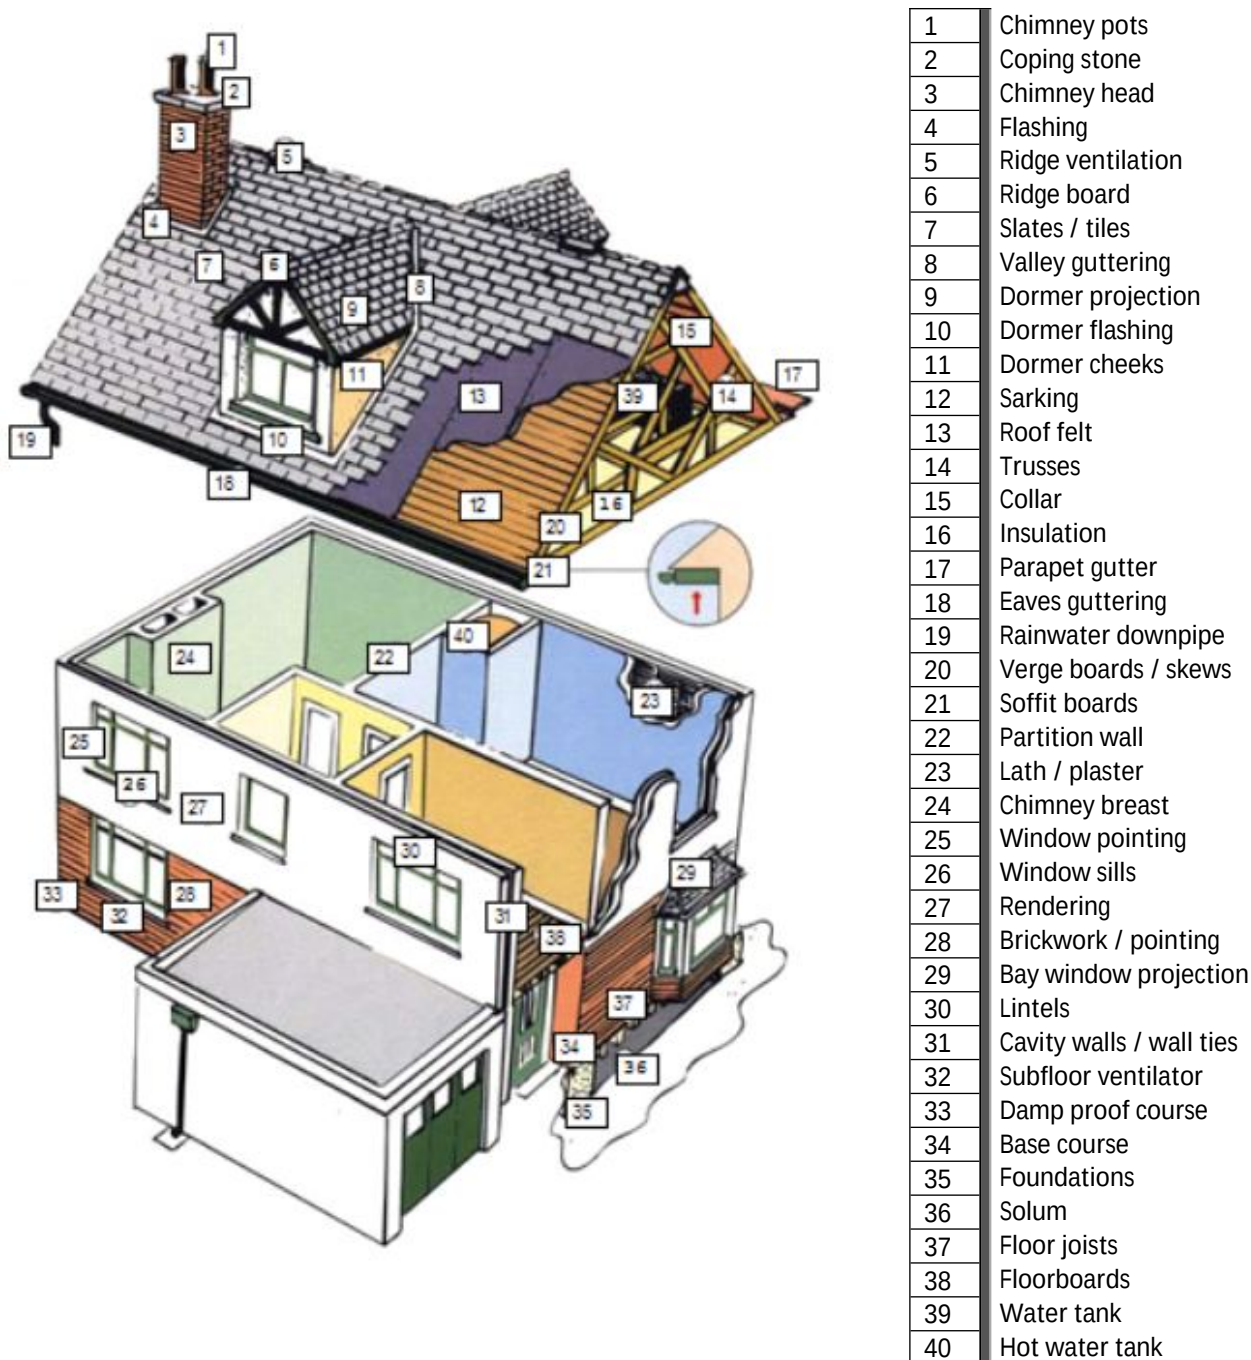
## Sectional diagram showing elements of a typical house

Reference may be made in this report to some or all of the above component parts of the property. This diagram may assist you in locating and understanding these items.
