Home Report

Scottish Single Survey

Single Survey

Property address	Doon Bye North Strome Lochcarron Strathcarron IV54 8YJ
Customer	Malcolm Guest
Customer address	Doon Bye North Strome Lochcarron Strathcarron IV54 8YJ
Prepared by	Shepherd Chartered Surveyors
Date of inspection	23/04/2026

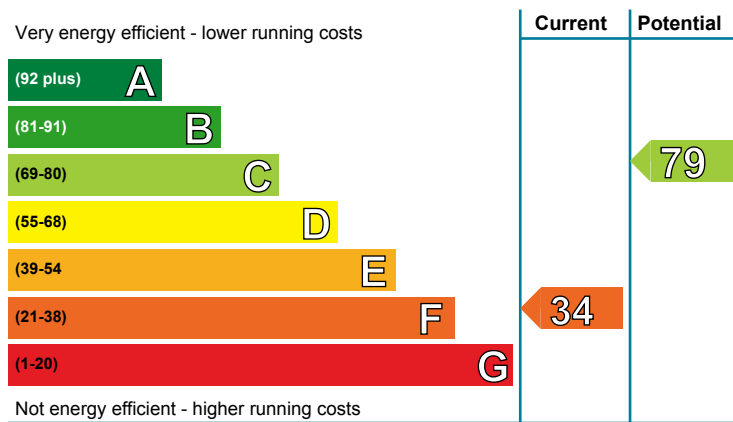
Energy Efficiency Rating

This graph shows the current efficiency of your home, taking into account both energy efficiency and fuel costs. The higher this rating, the lower your fuel bills are likely to be.

Your current rating is **band F (34)**. The average rating for EPCs in Scotland is **band D (61)**.

The potential rating shows the effect of undertaking all of the improvement measures listed within your recommendations report.

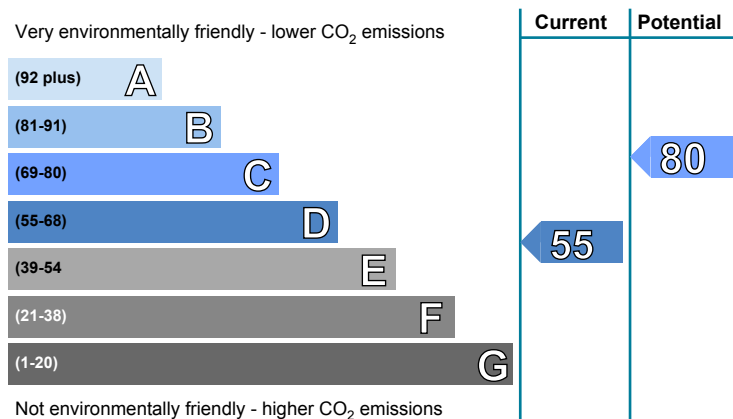
Environmental Impact (CO₂) Rating

This graph shows the effect of your home on the environment in terms of carbon dioxide (CO₂) emissions. The higher the rating, the less impact it has on the environment.
