## HOME REPORT

**5 THE PADDOCK  
SETON MAIN, LONGNIDDRY  
EH32 0PG**

**1<sup>st</sup> JULY 2026**

**NICHOLAS HAY, BSc (Hons) MRICS**

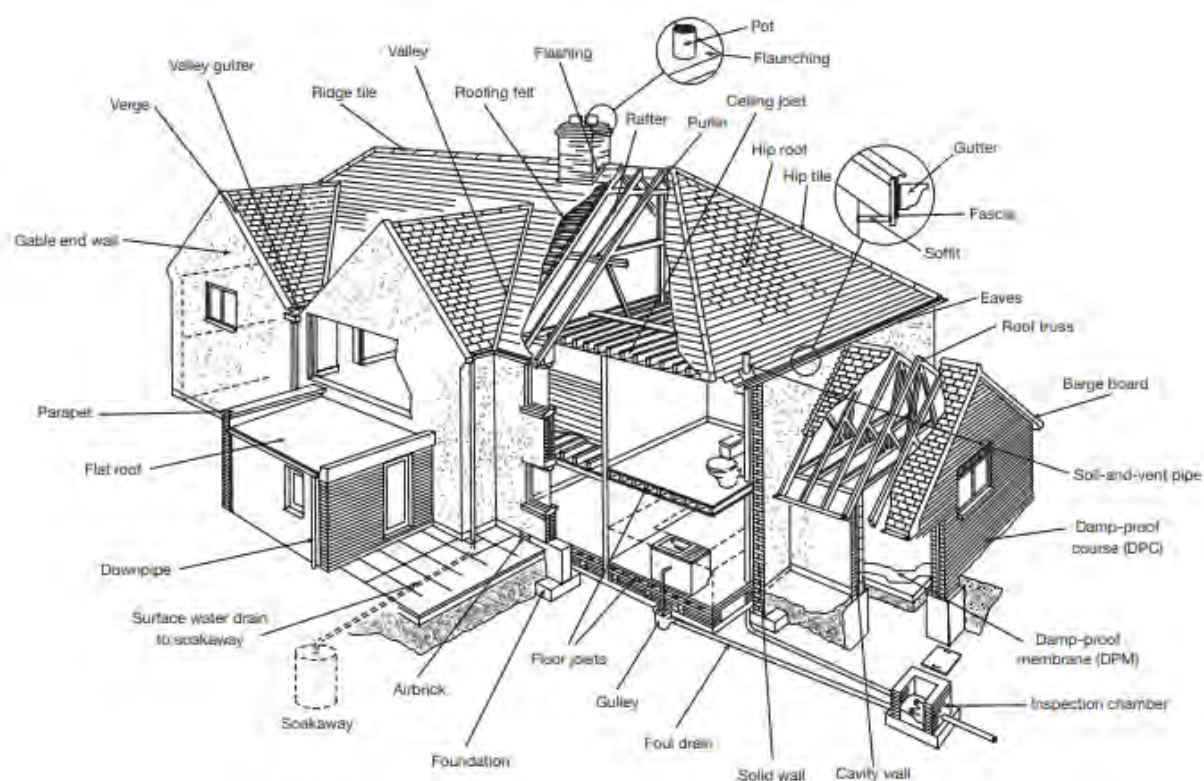
## Sectional diagram showing elements of a typical house

Reference may be made in this report to some or all of the above building elements of the property.

This diagram may assist you in locating and understanding these terms.

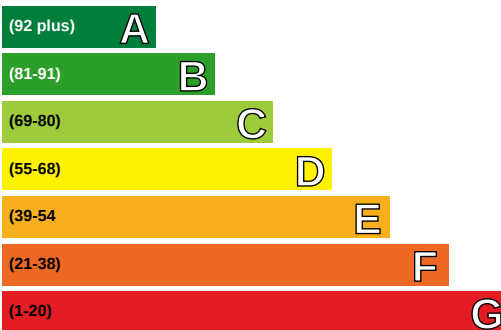
Very energy efficient - lower running costs

Not energy efficient - higher running costs

The potential rating shows the effect of undertaking all of the improvement measures listed within your recommendations report.

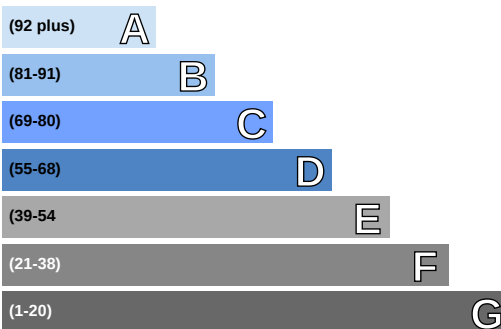
Very environmentally friendly - lower CO<sub>2</sub> emissions

Not environmentally friendly - higher CO<sub>2</sub> emissions
