SINGLE SURVEY

A report on the condition of the property, with categories being rated from 1 to 3.

Surveyor Reference	FB/3013
Customer	Executor of Georgina Allan
Selling address	58 Inchkeith Place Falkirk FK1 2PG
Date of Inspection	18/02/2026
Prepared by	Scott Livingstone, BSc (Hons) MRICS Falkirk - Allied Surveyors Scotland Ltd

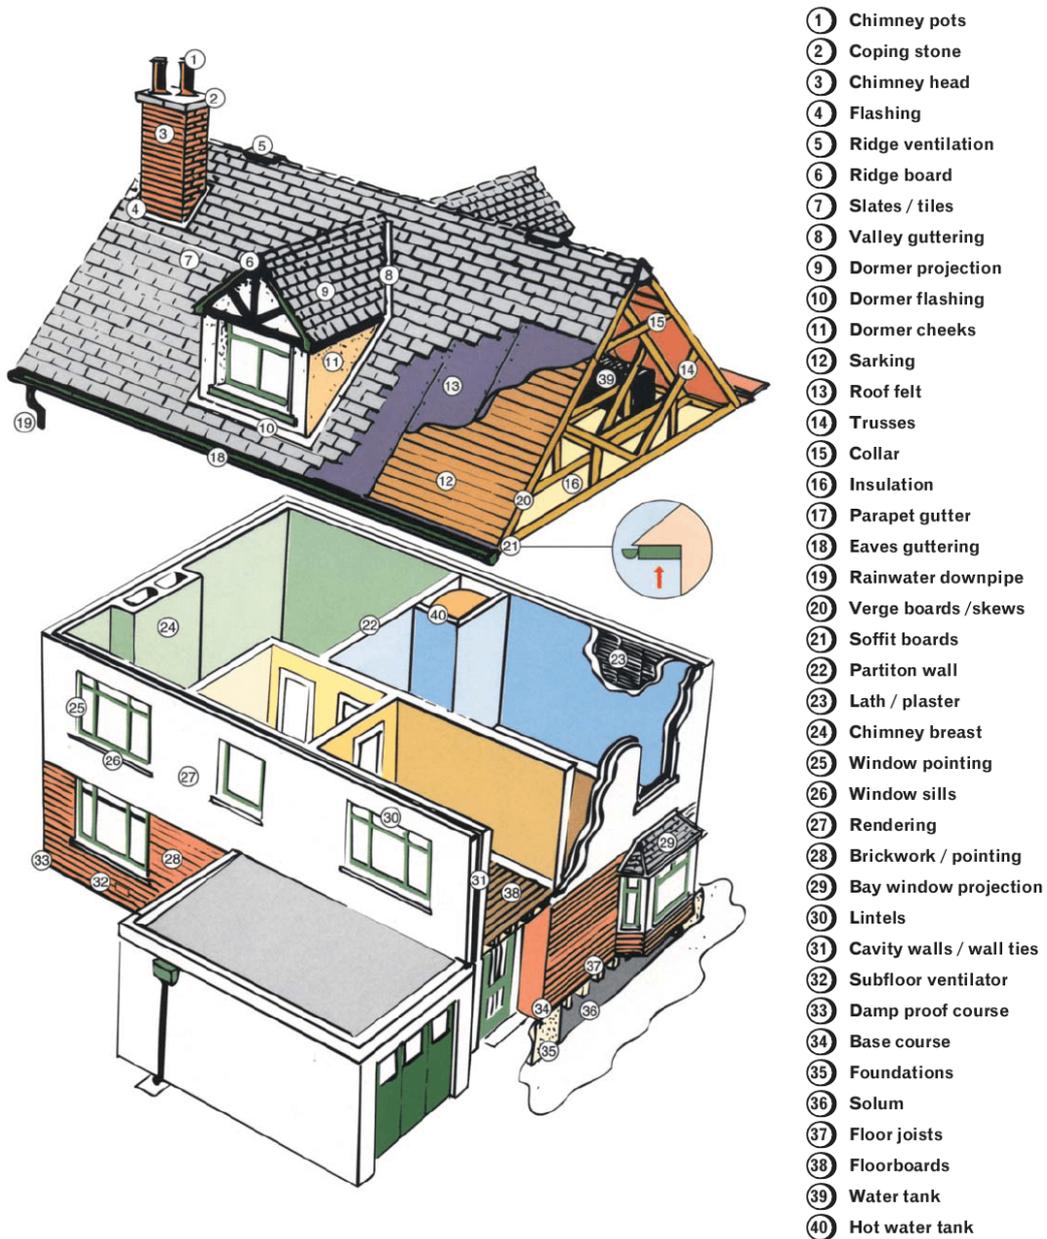
Sectional Diagram showing elements of a typical house

- ① Chimney pots
- ② Coping stone
- ③ Chimney head
- ④ Flashing
- ⑤ Ridge ventilation
- ⑥ Ridge board
- ⑦ Slates / tiles
- ⑧ Valley guttering
- ⑨ Dormer projection
- ⑩ Dormer flashing
- ⑪ Dormer cheeks
- ⑫ Sarking
- ⑬ Roof felt
- ⑭ Trusses
- ⑮ Collar
- ⑯ Insulation
- ⑰ Parapet gutter
- ⑱ Eaves guttering
- ⑲ Rainwater downpipe
- ⑳ Verge boards /skews
- ㉑ Soffit boards
- ㉒ Partiton wall
- ㉓ Lath / plaster
- ㉔ Chimney breast
- ㉕ Window pointing
- ㉖ Window sills
- ㉗ Rendering
- ㉘ Brickwork / pointing
- ㉙ Bay window projection
- ㉚ Lintels
- ㉛ Cavity walls / wall ties
- ㉜ Subfloor ventilator
- ㉝ Damp proof course
- ㉞ Base course
- ㉟ Foundations
- ㊱ Solum
- ㊲ Floor joists
- ㊳ Floorboards
- ㊴ Water tank
- ㊵ Hot water tank

Reference may be made in this report to some or all of the above component parts of the property. This diagram may assist you in locating and understanding these items.
