# Home Report

## 5 Mulroy Terrace Roy Bridge PH31 4AF

Inspected on: 5<sup>th</sup> August 2026

**Prepared by:**  
Samuel & Partners  
First Surveyors Scotland  
First Floor  
20 High Street  
FORT WILLIAM  
PH33 6AT

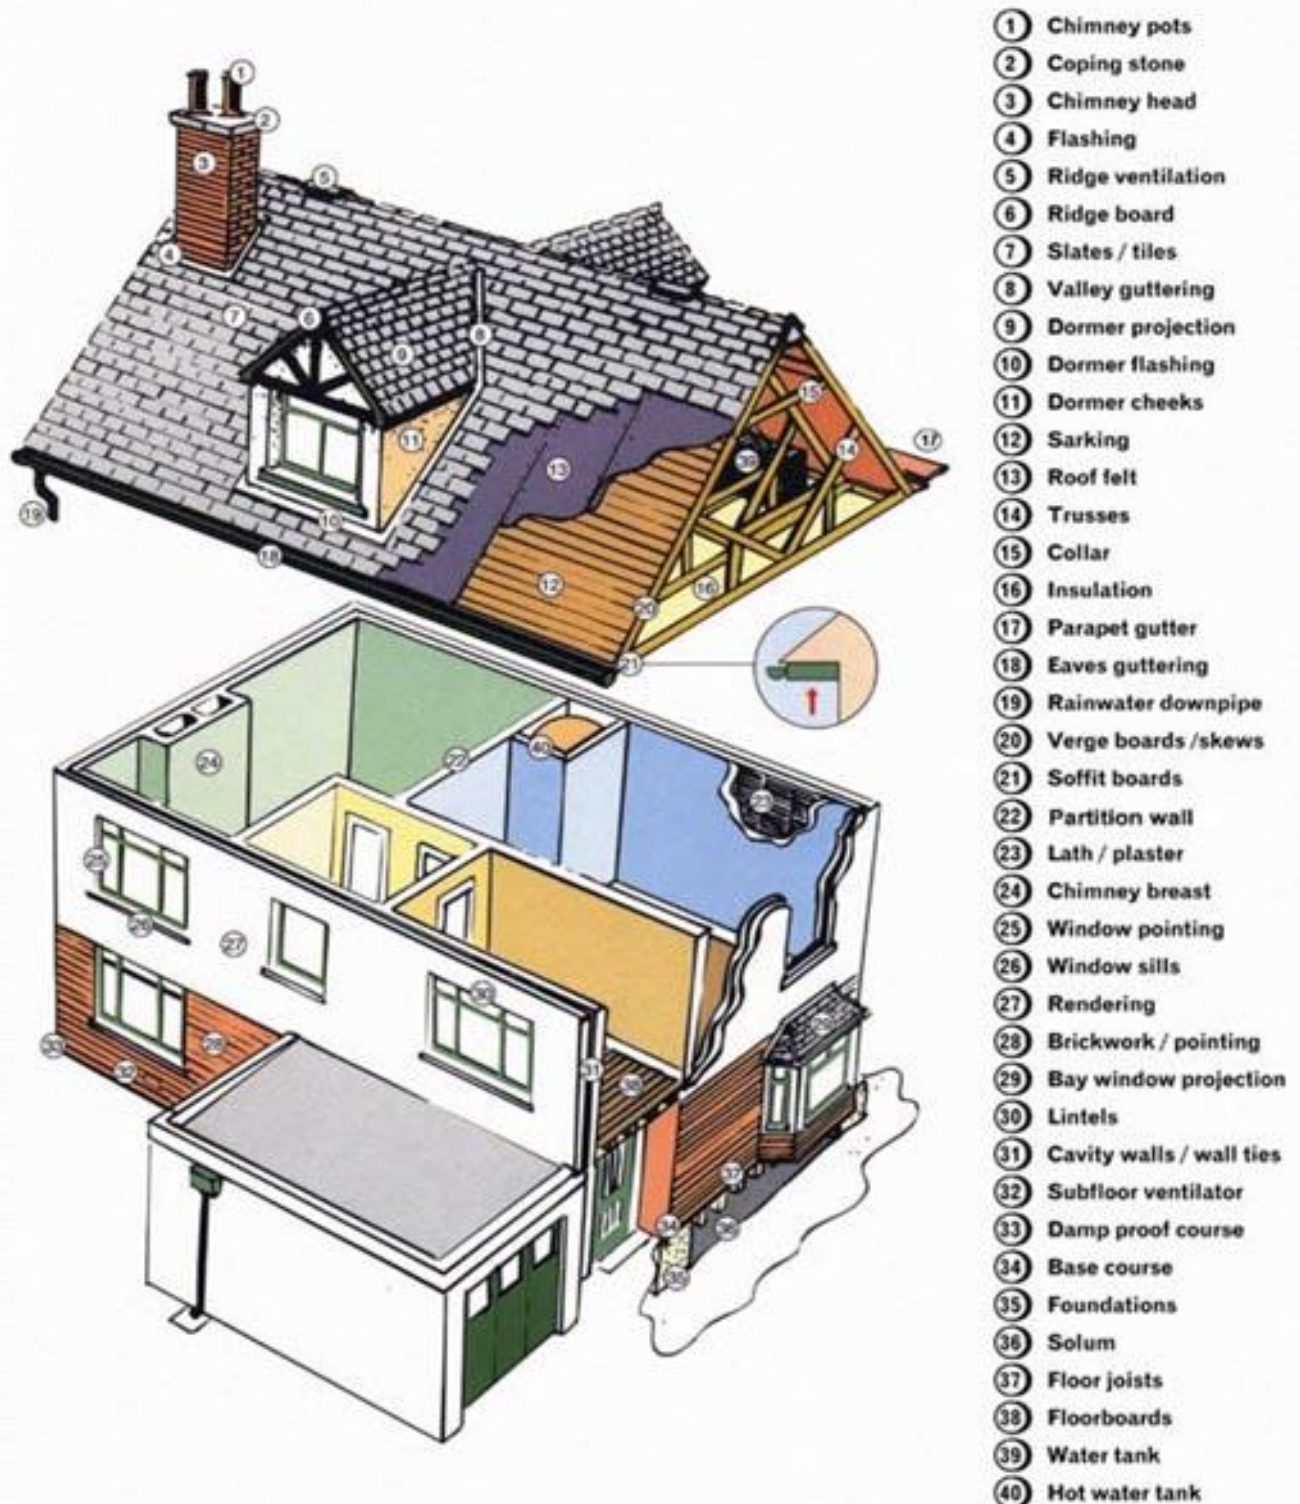
## Sectional Diagram showing elements of a typical house

Reference may be made in this report to some or all of the above component parts of the property. This diagram may assist you in locating and understanding these items.
