Home Report

Contents

Single Survey

Property address	29 James Young Avenue Uphall Station Livingston EH54 5FA
Customer	Mr and Mrs Walker
Customer address	29 James Young Avenue Uphall Station Livingston EH54 5FA
Prepared by	Shepherd Chartered Surveyors
Date of inspection	07/07/2026

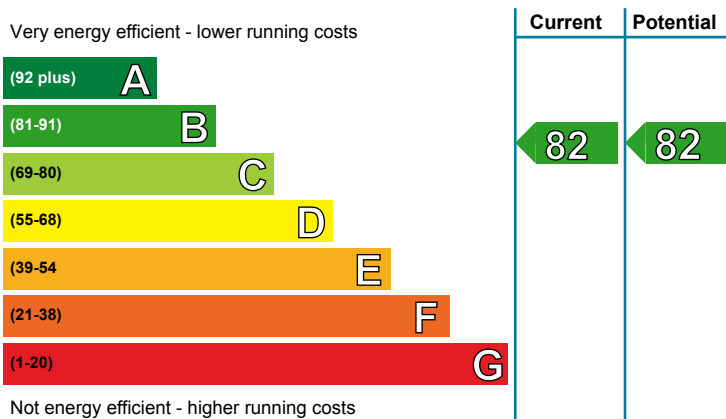
Energy Efficiency Rating

This graph shows the current efficiency of your home, taking into account both energy efficiency and fuel costs. The higher this rating, the lower your fuel bills are likely to be.

Your current rating is **band B (82)**. The average rating for EPCs in Scotland is **band D (61)**.

The potential rating shows the effect of undertaking all of the improvement measures listed within your recommendations report.
