# Home Report

Woodend Cottage,  
Woodend Road,  
Gauldry,  
Newport on Tay,  
DD6 8RW

# Single Survey

## Survey Report on:

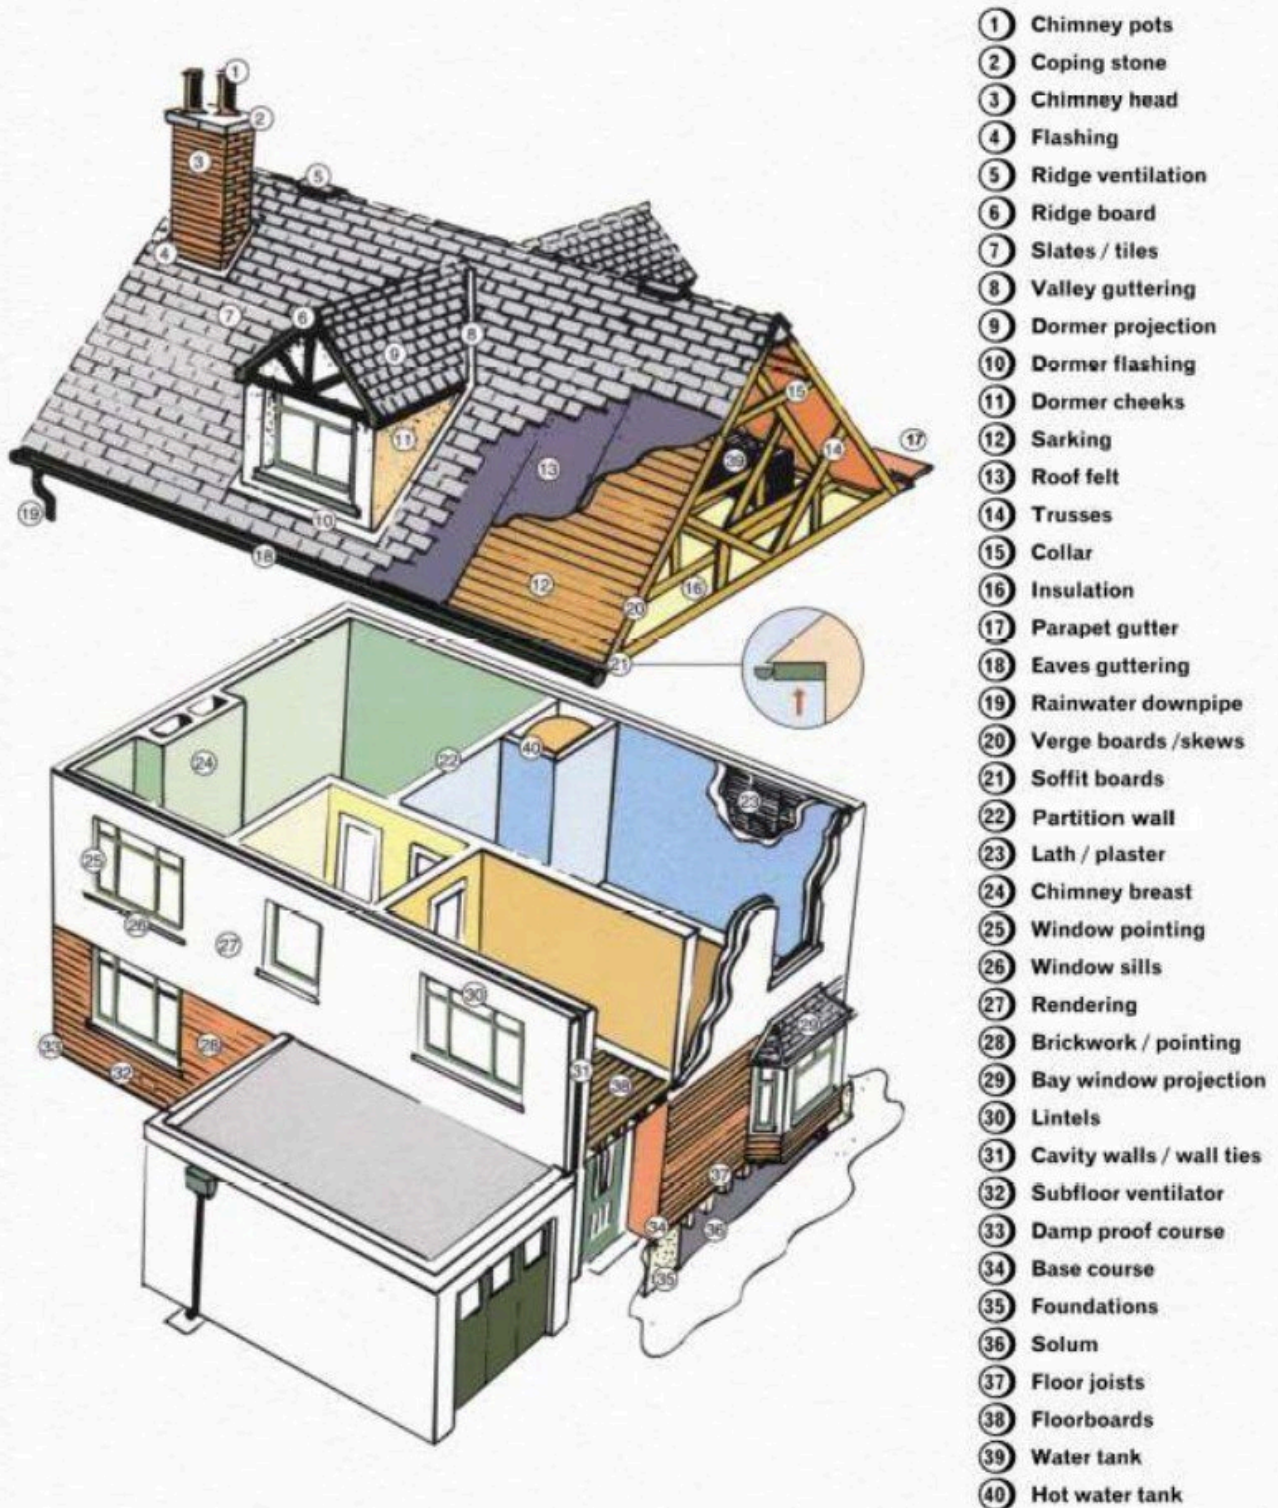
## Sectional Diagram showing elements of a typical house

Reference may be made in this report to some or all of the above component parts of the property. This diagram may assist you in locating and understanding these items.

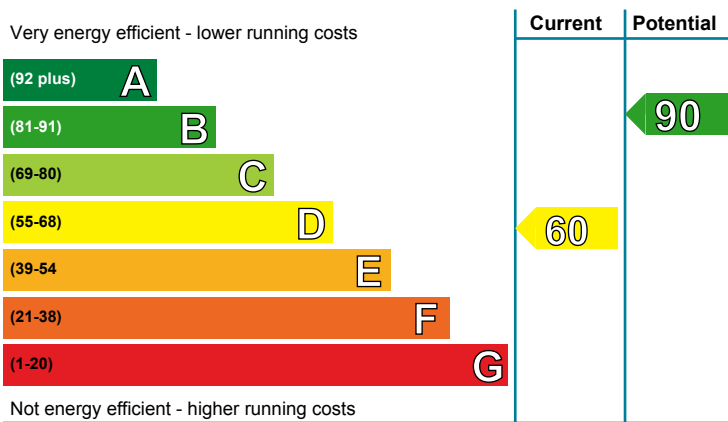
## Energy Efficiency Rating

This graph shows the current efficiency of your home, taking into account both energy efficiency and fuel costs. The higher this rating, the lower your fuel bills are likely to be.

Your current rating is **band D (60)**. The average rating for EPCs in Scotland is **band D (61)**.

The potential rating shows the effect of undertaking all of the improvement measures listed within your recommendations report.

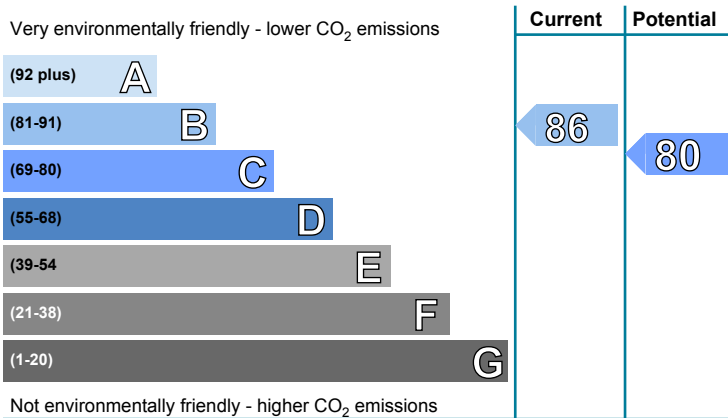
## Environmental Impact (CO<sub>2</sub>) Rating

This graph shows the effect of your home on the environment in terms of carbon dioxide (CO<sub>2</sub>) emissions. The higher the rating, the less impact it has on the environment.
