HOME
report

SINGLE SURVEY
ENERGY REPORT
PROPERTY QUESTIONNAIRE
VALUATION REPORT

Single Survey

Property Address	101 Langton View East Calder Livingston EH53 0RB
Customer	Santander
Date of Inspection	17/10/2025
Prepared by	Nick Bonnar Harvey Donaldson & Gibson Chartered Surveyors

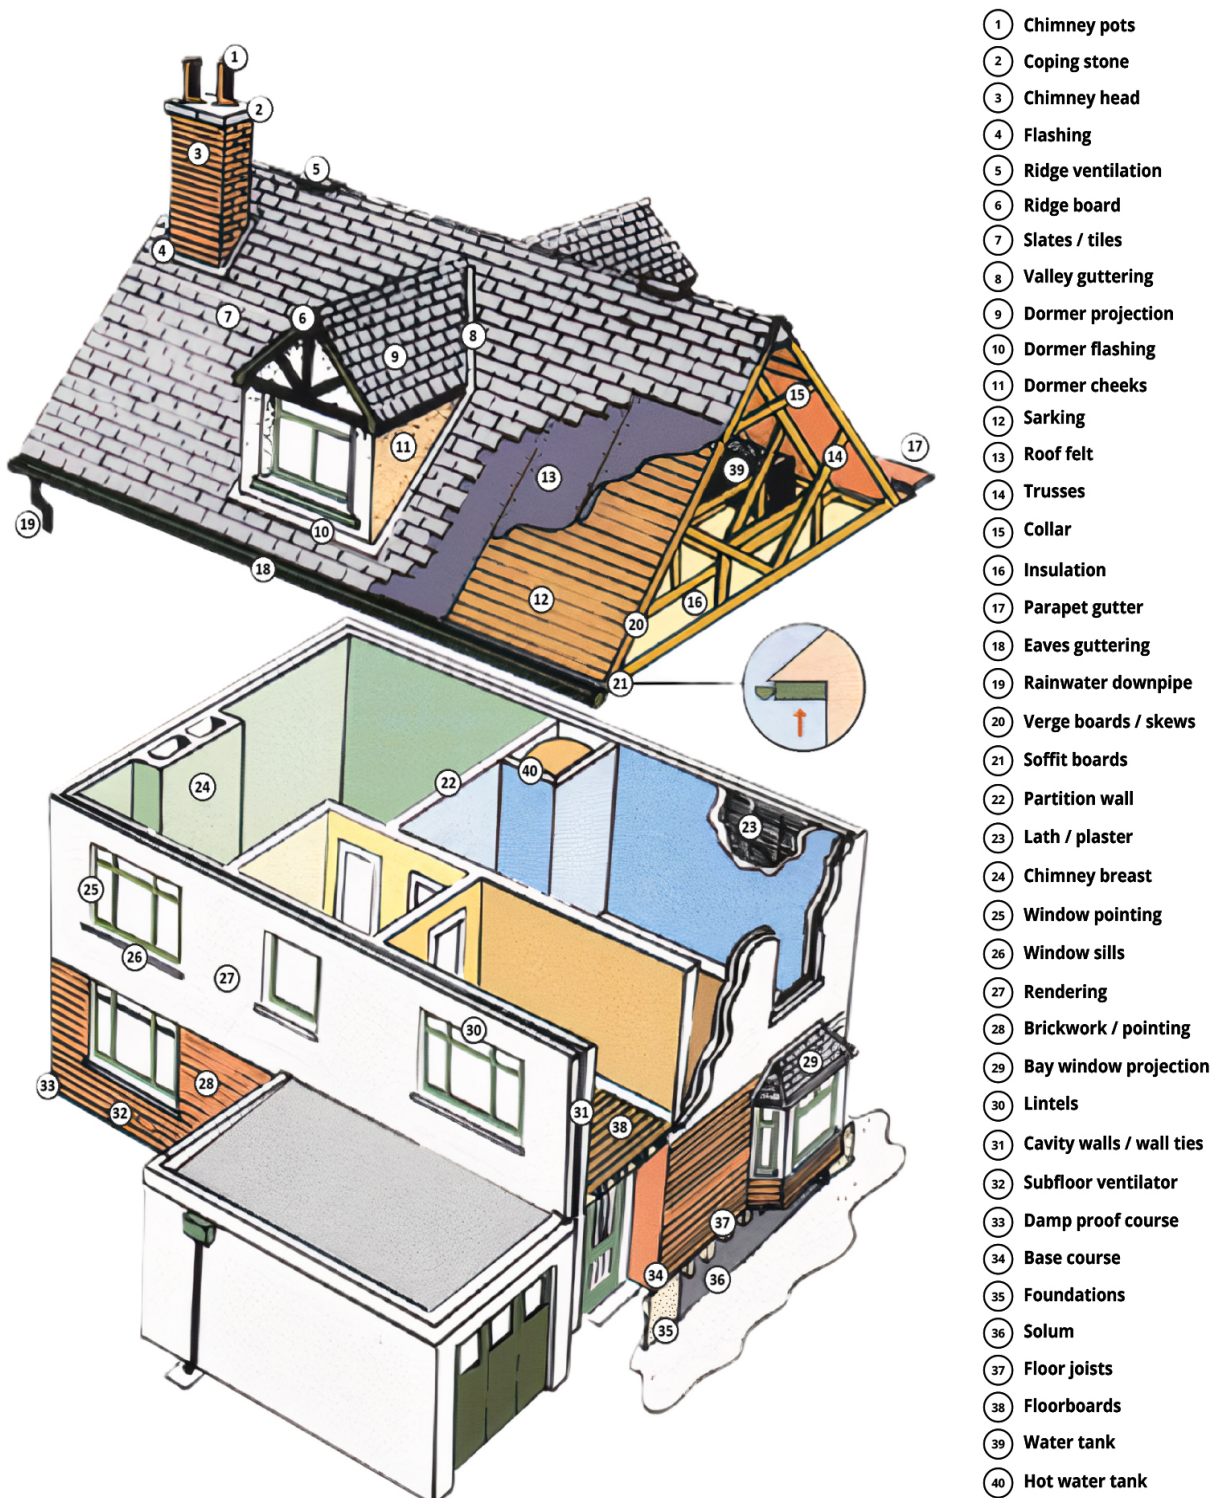
Sectional Diagram showing elements of a typical house

Reference may be made in this report to some or all of the above component parts of the property. This diagram may assist you in locating and understanding these items.
