# YOUR ONESURVEY HOME REPORT

2 Craighton Cottages  
Milngavie  
Glasgow  
G62 7HQ

# Single Survey

# Mortgage Valuation Report

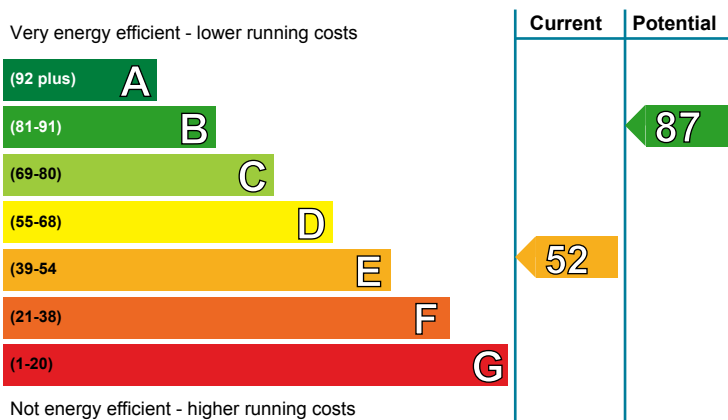
## Energy Efficiency Rating

This graph shows the current efficiency of your home, taking into account both energy efficiency and fuel costs. The higher this rating, the lower your fuel bills are likely to be.

Your current rating is **band E (52)**. The average rating for EPCs in Scotland is **band D (61)**.

The potential rating shows the effect of undertaking all of the improvement measures listed within your recommendations report.

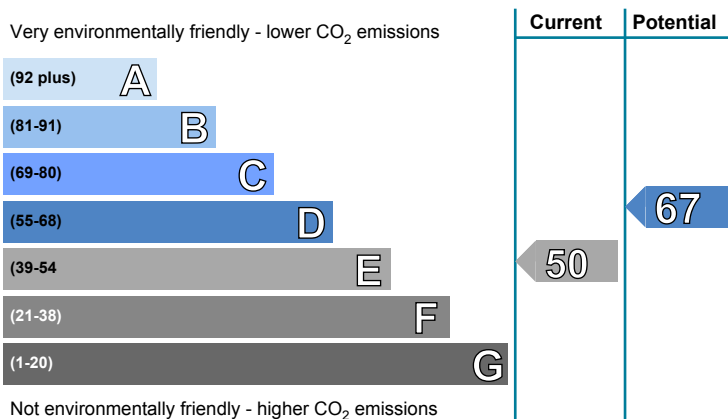
## Environmental Impact (CO<sub>2</sub>) Rating

This graph shows the effect of your home on the environment in terms of carbon dioxide (CO<sub>2</sub>) emissions. The higher the rating, the less impact it has on the environment.
