# Single Survey

survey report on:

| Property address | 27 Marchwood Crescent<br>Bathgate<br>EH48 1DA |
| Prepared by | Shepherd Chartered Surveyors |

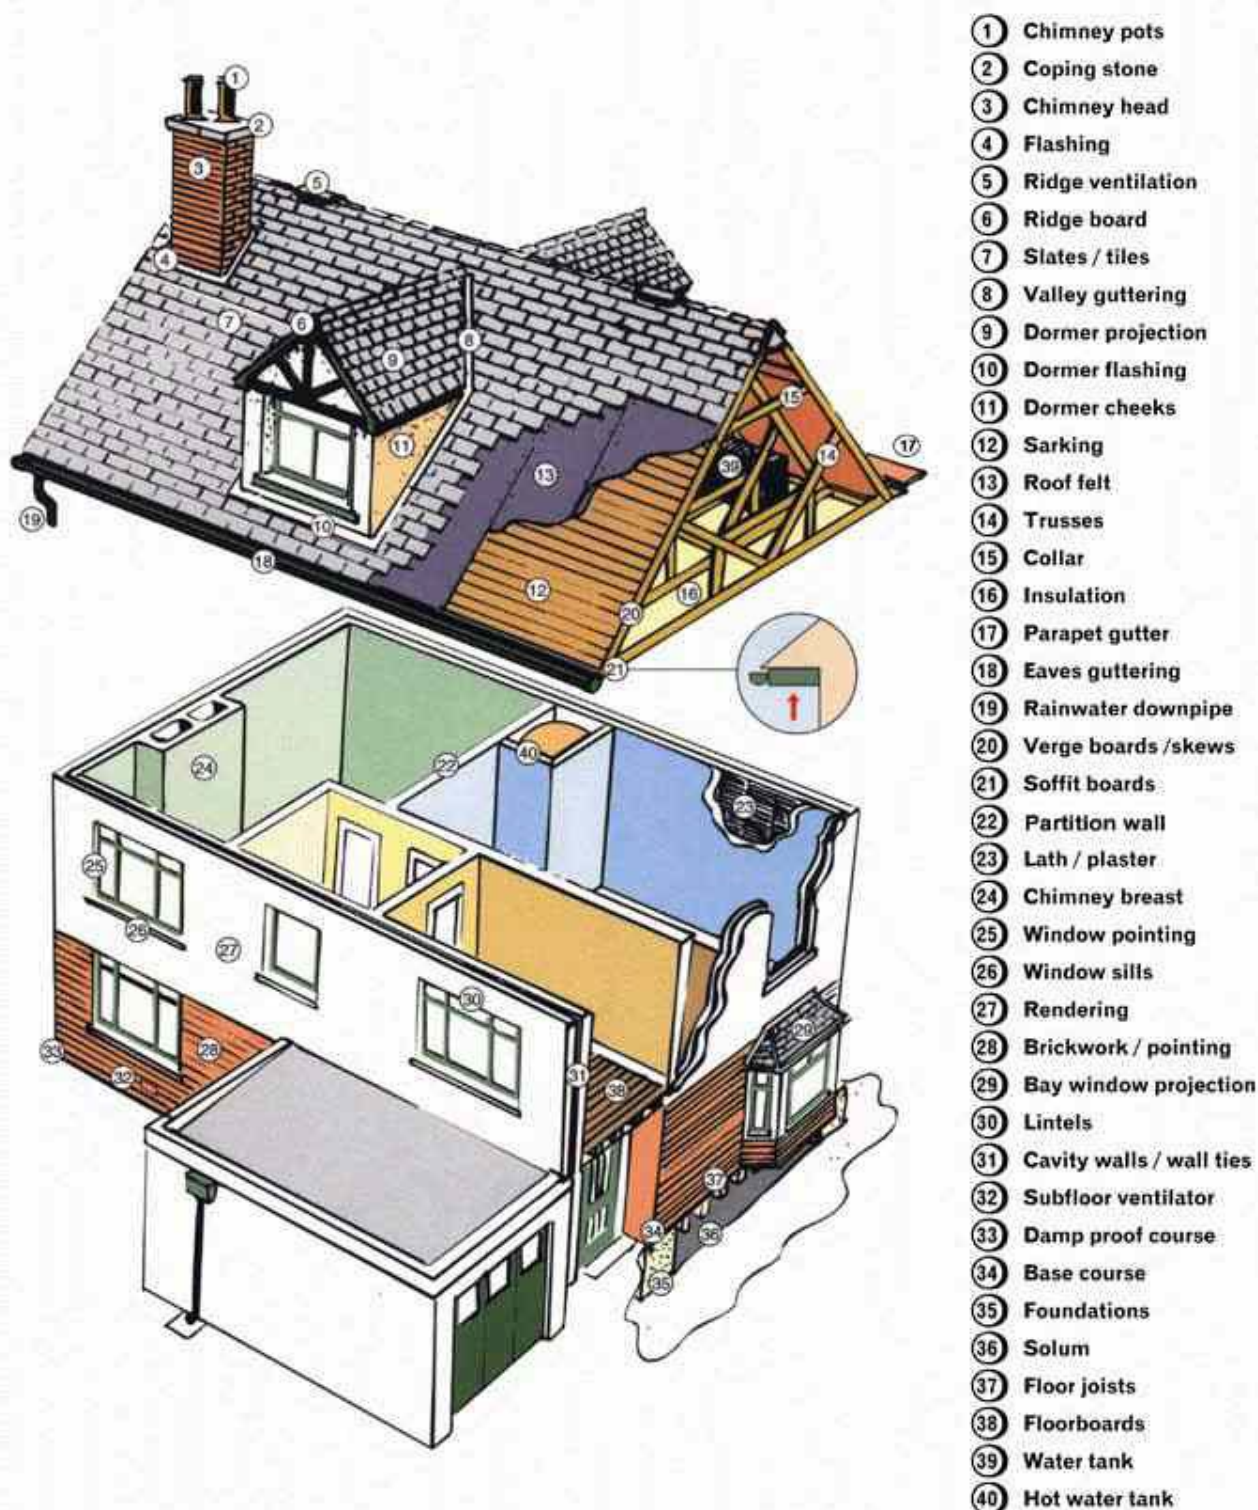
## Sectional Diagram showing elements of a typical house

Reference may be made in this report to some or all of the above component parts of the property. This diagram may assist you in locating and understanding these items.
