# Home Report

13A Trinity Road  
Brechin DD9 6BE

# Single Survey

<b>Property Address</b>	13A Trinity Road Brechin DD9 6BE
<b>Customer</b>	L McDowall as guardian for A Mitchell
<b>Prepared by</b>	Graham + Sibbald Property Consultants Limited
<b>Date of Inspection</b>	16/12/2025

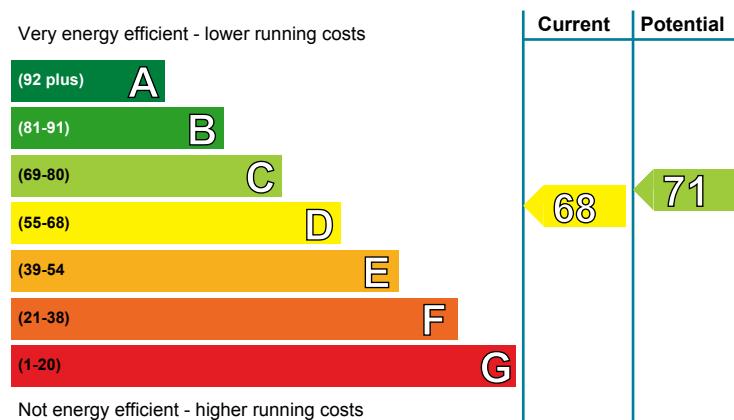
## Energy Efficiency Rating

This graph shows the current efficiency of your home, taking into account both energy efficiency and fuel costs. The higher this rating, the lower your fuel bills are likely to be.

Your current rating is **band D (68)**. The average rating for EPCs in Scotland is **band D (61)**.

The potential rating shows the effect of undertaking all of the improvement measures listed within your recommendations report.

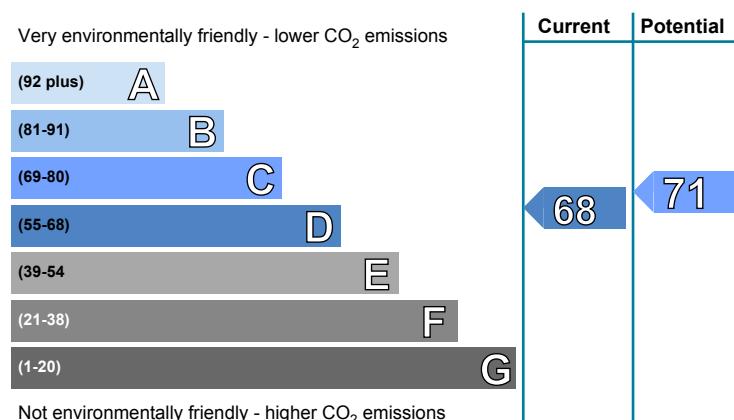
## Environmental Impact (CO<sub>2</sub>) Rating

This graph shows the effect of your home on the environment in terms of carbon dioxide (CO<sub>2</sub>) emissions. The higher the rating, the less impact it has on the environment.
