Home Report

Single Survey

Property address	0/1 272 Darnley Street Glasgow G41 2JA
Customer	Executors of Mima Tanner
Customer address	0/1 272 Darnley Street Glasgow G41 2JA
Prepared by	Shepherd Chartered Surveyors
Date of inspection	30/03/2026

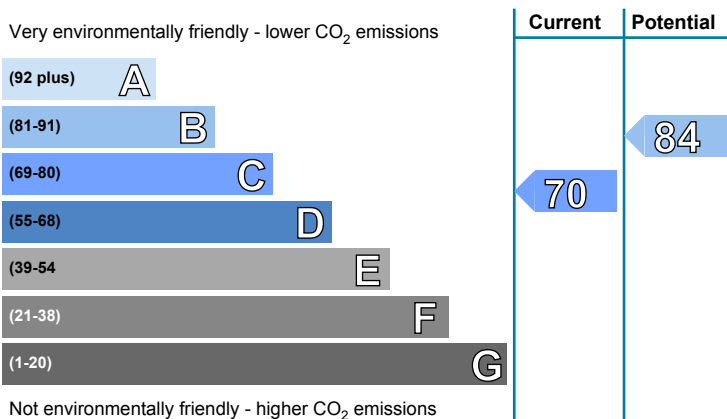
Environmental Impact (CO₂) Rating

This graph shows the effect of your home on the environment in terms of carbon dioxide (CO₂) emissions. The higher the rating, the less impact it has on the environment.
