YOUR ONESURVEY  
**HOME REPORT**

2 The Square  
New Abbey, Dumfries  
DG2 8BX

# SINGLE SURVEY

A report on the condition of the property, with categories  
being rated from 1 to 3.

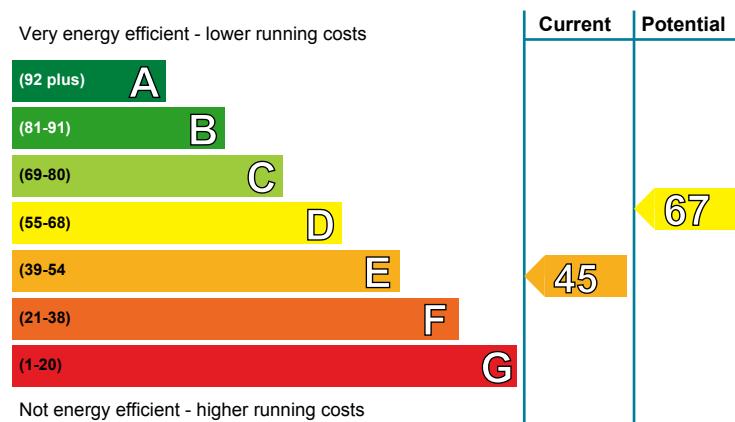
### Energy Efficiency Rating

This graph shows the current efficiency of your home, taking into account both energy efficiency and fuel costs. The higher this rating, the lower your fuel bills are likely to be.

Your current rating is **band E (45)**. The average rating for EPCs in Scotland is **band D (61)**.

The potential rating shows the effect of undertaking all of the improvement measures listed within your recommendations report.

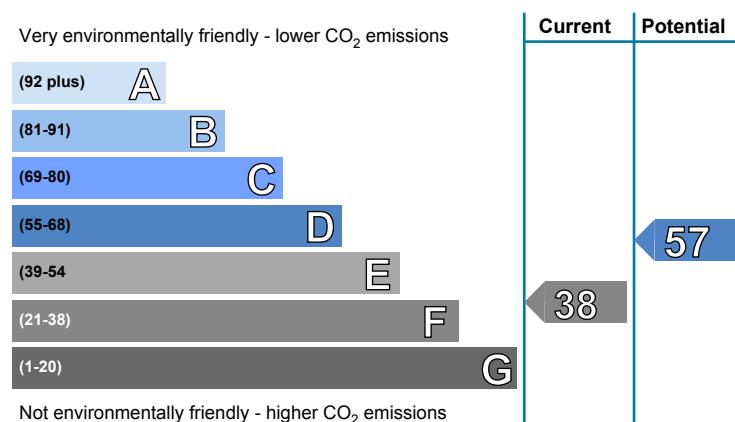
### Environmental Impact (CO<sub>2</sub>) Rating

This graph shows the effect of your home on the environment in terms of carbon dioxide (CO<sub>2</sub>) emissions. The higher the rating, the less impact it has on the environment.
