Dunchonnel,
Cullipool,
Isle of Luing,
PA34 4TX

Home Report

Single Survey

Survey Report on:

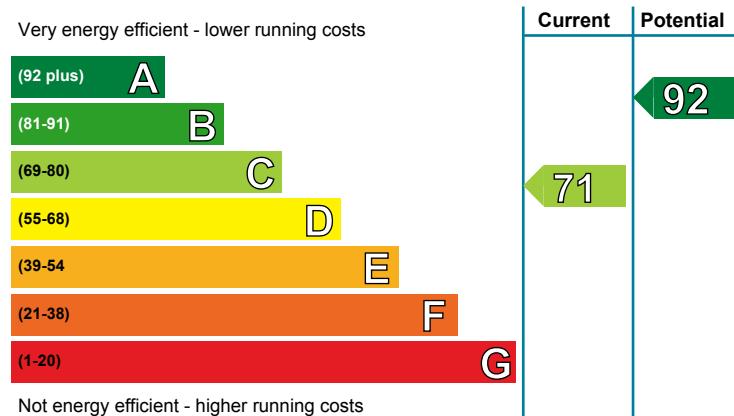
Energy Efficiency Rating

This graph shows the current efficiency of your home, taking into account both energy efficiency and fuel costs. The higher this rating, the lower your fuel bills are likely to be.

Your current rating is **band C (71)**. The average rating for EPCs in Scotland is **band D (61)**.

The potential rating shows the effect of undertaking all of the improvement measures listed within your recommendations report.

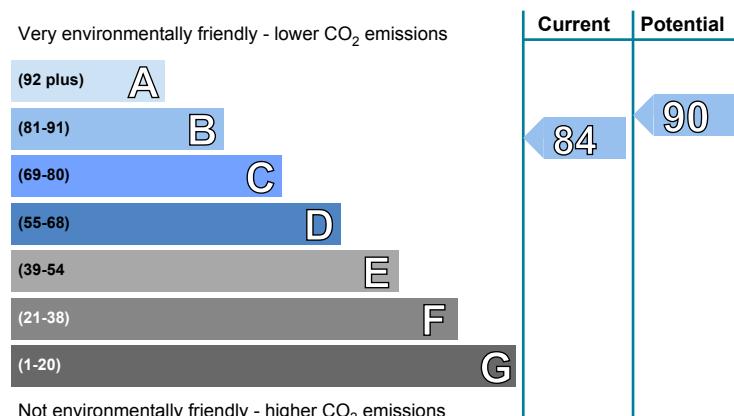
Environmental Impact (CO₂) Rating

This graph shows the effect of your home on the environment in terms of carbon dioxide (CO₂) emissions. The higher the rating, the less impact it has on the environment.
