Home Report

26b Afton Road,
Cumbernauld,
GLASGOW,
G67 2ET

Single Survey

Property Address	26b Afton Road, Cumbernauld, GLASGOW, G67 2ET
Reference	1578197
Customer Name	Rebecca McIntyre
Date of Inspection	13th May 2026
Surveyor's name, qualifications and office	Derek Anderson MRICS DM Hall LLP Chartered Surveyors Suite 2C 1 Pitt Terrace Stirling FK8 2EZ Tel: 01786 475785 email: stirlingresidential@dmhall.co.uk
Prepared By	DM Hall LLP

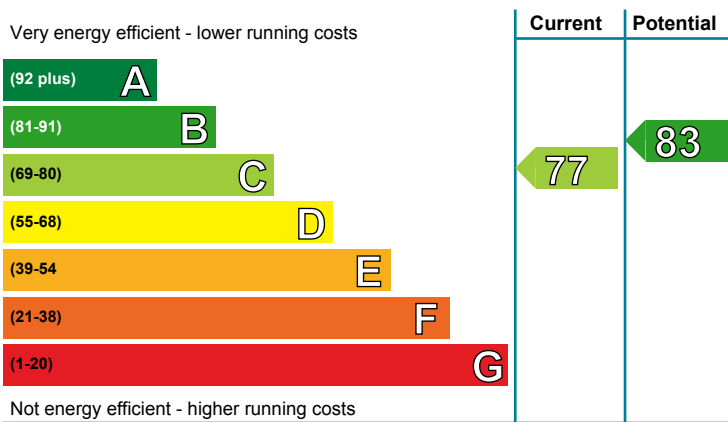
Energy Efficiency Rating

This graph shows the current efficiency of your home, taking into account both energy efficiency and fuel costs. The higher this rating, the lower your fuel bills are likely to be.

Your current rating is **band C (77)**. The average rating for EPCs in Scotland is **band D (61)**.

The potential rating shows the effect of undertaking all of the improvement measures listed within your recommendations report.
