**45 Carn Dearg Road
Claggan
Fort William
PH33 6QQ**

Inspected on: 5th May 2026

Prepared by:
Samuel & Partners
First Surveyors Scotland
First Floor
20 High Street
FORT WILLIAM
PH33 6AT

H o m e R e p o r t - i n d e x

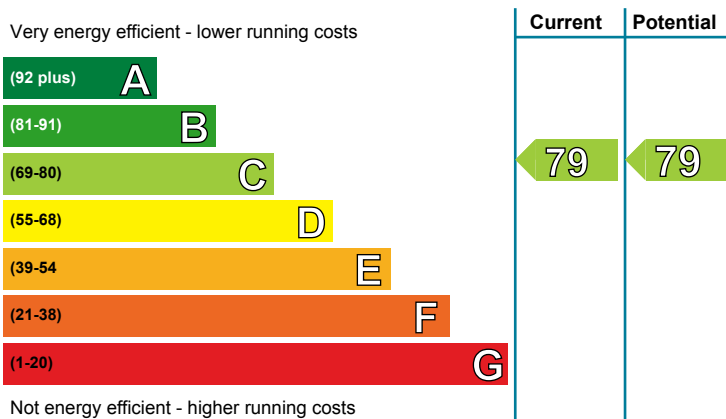
Energy Efficiency Rating

This graph shows the current efficiency of your home, taking into account both energy efficiency and fuel costs. The higher this rating, the lower your fuel bills are likely to be.

Your current rating is **band C (79)**. The average rating for EPCs in Scotland is **band D (61)**.

The potential rating shows the effect of undertaking all of the improvement measures listed within your recommendations report.
