Single Survey

survey report on:

Property address	Flat G 2 Union Lane Ellon AB41 9DS
Customer	Stella 4 Property Ltd.
Customer address	Flat G 2 Union Lane Ellon AB41 9DS
Prepared by	Shepherd Chartered Surveyors
Date of inspection	04/07/2025

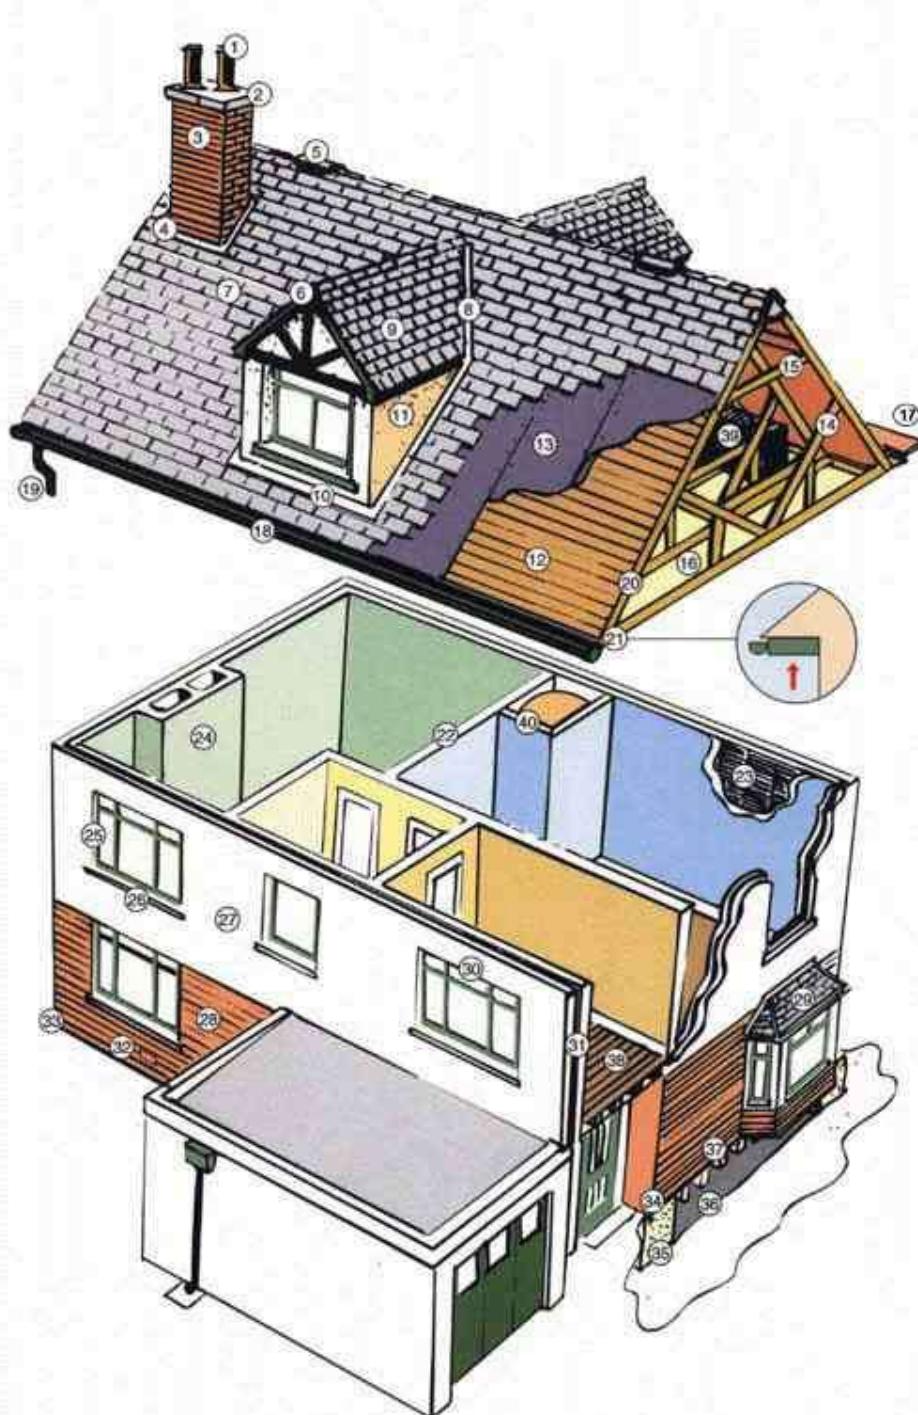
Sectional Diagram showing elements of a typical house

- 1 Chimney pots
- 2 Coping stone
- 3 Chimney head
- 4 Flashing
- 5 Ridge ventilation
- 6 Ridge board
- 7 Slates / tiles
- 8 Valley guttering
- 9 Dormer projection
- 10 Dormer flashing
- 11 Dormer cheeks
- 12 Sarking
- 13 Roof felt
- 14 Trusses
- 15 Collar
- 16 Insulation
- 17 Parapet gutter
- 18 Eaves guttering
- 19 Rainwater downpipe
- 20 Verge boards /skews
- 21 Soffit boards
- 22 Partition wall
- 23 Lath / plaster
- 24 Chimney breast
- 25 Window pointing
- 26 Window sills
- 27 Rendering
- 28 Brickwork / pointing
- 29 Bay window projection
- 30 Lintels
- 31 Cavity walls / wall ties
- 32 Subfloor ventilator
- 33 Damp proof course
- 34 Base course
- 35 Foundations
- 36 Solum
- 37 Floor joists
- 38 Floorboards
- 39 Water tank
- 40 Hot water tank

Reference may be made in this report to some or all of the above component parts of the property. This diagram may assist you in locating and understanding these items.
