Home Report

Failte
Strathdon
AB36 8UR

Single Survey and Mortgage Valuation Report

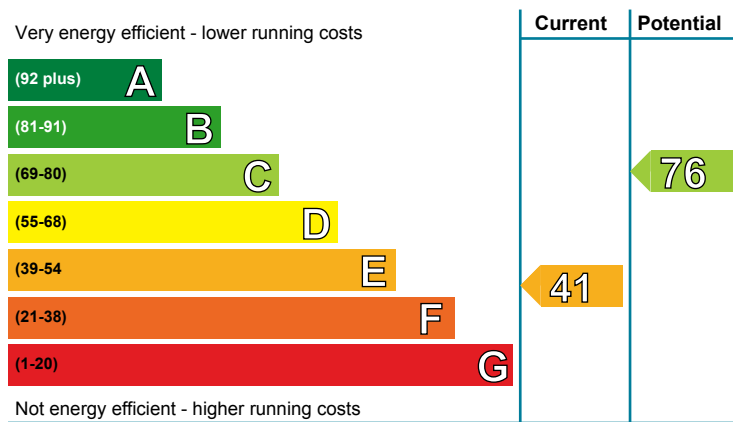
Energy Efficiency Rating

This graph shows the current efficiency of your home, taking into account both energy efficiency and fuel costs. The higher this rating, the lower your fuel bills are likely to be.

Your current rating is **band E (41)**. The average rating for EPCs in Scotland is **band D (61)**.

The potential rating shows the effect of undertaking all of the improvement measures listed within your recommendations report.
