# Home Report

# Scottish Single Survey

| Property address | 0/1<br>21 Greenlaw Avenue<br>Paisley<br>PA1 3RB |

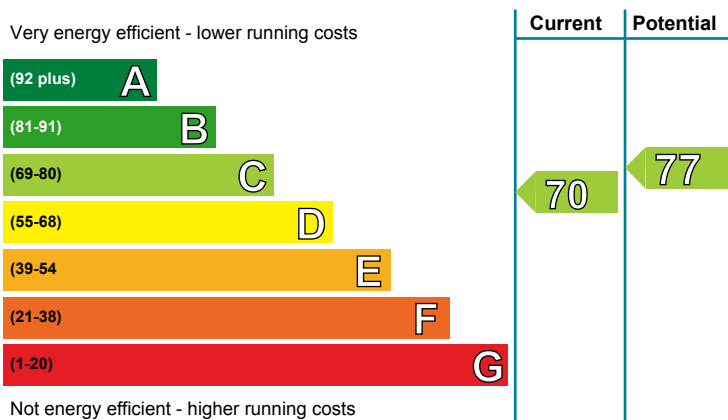
## Energy Efficiency Rating

This graph shows the current efficiency of your home, taking into account both energy efficiency and fuel costs. The higher this rating, the lower your fuel bills are likely to be.

Your current rating is **band C (70)**. The average rating for EPCs in Scotland is **band D (61)**.

The potential rating shows the effect of undertaking all of the improvement measures listed within your recommendations report.

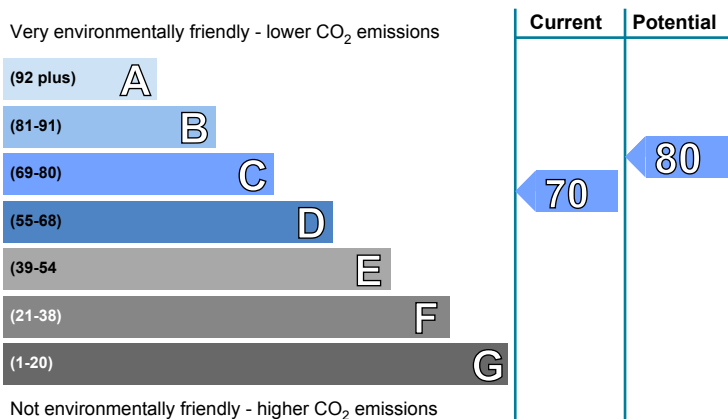
## Environmental Impact (CO<sub>2</sub>) Rating

This graph shows the effect of your home on the environment in terms of carbon dioxide (CO<sub>2</sub>) emissions. The higher the rating, the less impact it has on the environment.
