# Home Report

# Single Survey

| Property address | 42 Shillinghill<br>Alness<br>IV17 0SZ |
| Prepared by | Shepherd Chartered Surveyors |

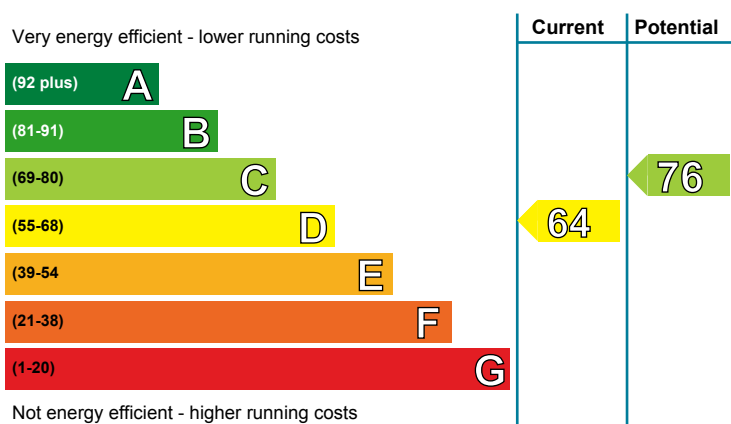
## Energy Efficiency Rating

This graph shows the current efficiency of your home, taking into account both energy efficiency and fuel costs. The higher this rating, the lower your fuel bills are likely to be.

Your current rating is **band D (64)**. The average rating for EPCs in Scotland is **band D (61)**.

The potential rating shows the effect of undertaking all of the improvement measures listed within your recommendations report.

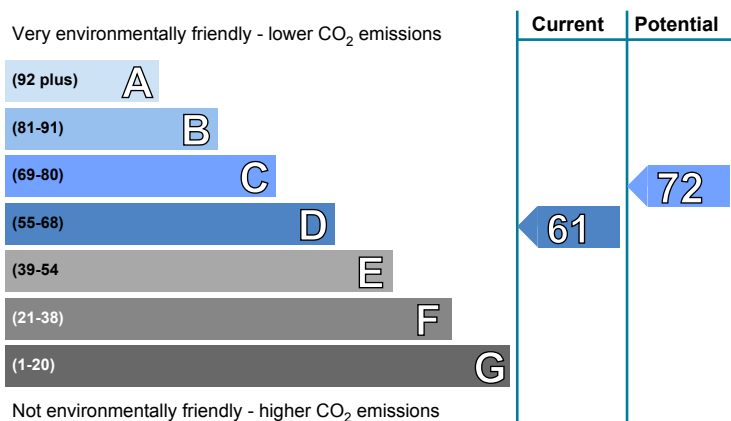
## Environmental Impact (CO<sub>2</sub>) Rating

This graph shows the effect of your home on the environment in terms of carbon dioxide (CO<sub>2</sub>) emissions. The higher the rating, the less impact it has on the environment.
