# Home Report

# Scottish Single Survey

<b>Property address</b>	Woodhead Cottage Middlebie Lockerbie DG11 3JW
-------------------------	--

<b>Prepared by</b>	Shepherd Chartered Surveyors
--------------------	------------------------------

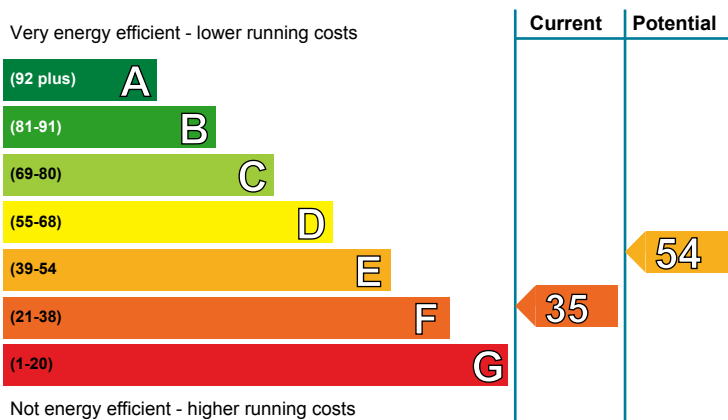
## Energy Efficiency Rating

This graph shows the current efficiency of your home, taking into account both energy efficiency and fuel costs. The higher this rating, the lower your fuel bills are likely to be.

Your current rating is **band F (35)**. The average rating for EPCs in Scotland is **band D (61)**.

The potential rating shows the effect of undertaking all of the improvement measures listed within your recommendations report.

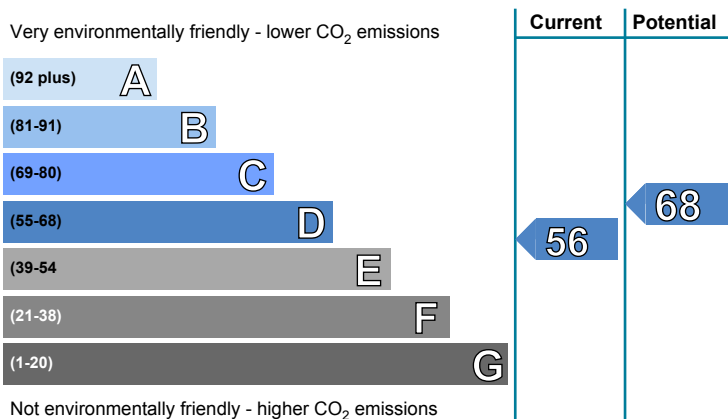
## Environmental Impact (CO<sub>2</sub>) Rating

This graph shows the effect of your home on the environment in terms of carbon dioxide (CO<sub>2</sub>) emissions. The higher the rating, the less impact it has on the environment.
