movementmachine | HOME REPORT

Lochmill Cottage  
Rosemill Road  
Bridgefoot  
Dundee  
DD3 0RW  
23/06/2025

# Single Survey

<b>Property address</b>	Lochmill, Rosemill Road, Bridgefoot, Dundee, DD3 0RW
<b>Customer</b>	Mrs Stella Dailly and Mrs Anne Holt
<b>Customer address</b>	c/o Lindsays, Seabraes House, 18 Greenmarket, Dundee, DD3 0RW
<b>Prepared by</b>	Graham + Sibbald
<b>Date of inspection</b>	4th June 2025

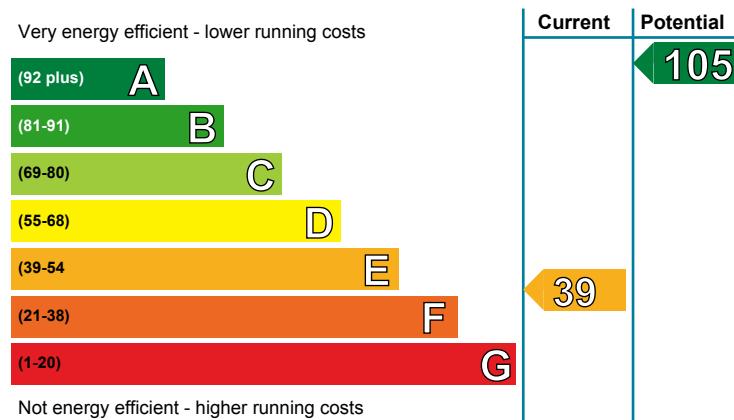
## Energy Efficiency Rating

This graph shows the current efficiency of your home, taking into account both energy efficiency and fuel costs. The higher this rating, the lower your fuel bills are likely to be.

Your current rating is **band E (39)**. The average rating for EPCs in Scotland is **band D (61)**.

The potential rating shows the effect of undertaking all of the improvement measures listed within your recommendations report.

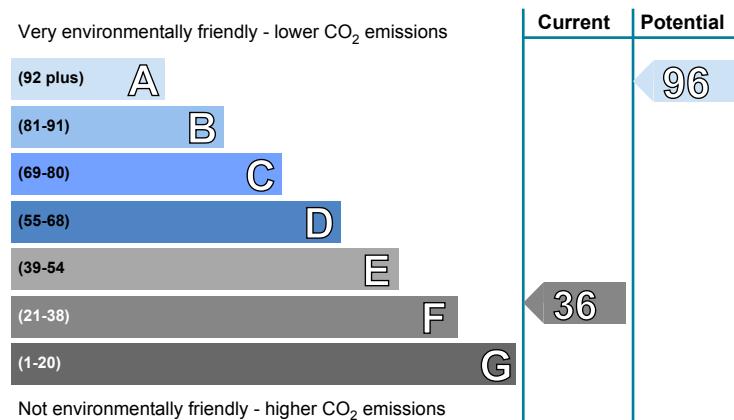
## Environmental Impact (CO<sub>2</sub>) Rating

This graph shows the effect of your home on the environment in terms of carbon dioxide (CO<sub>2</sub>) emissions. The higher the rating, the less impact it has on the environment.
