YOUR ONESURVEY
HOME REPORT

Flat 3/1
464 Crow Road
Glasgow
G11 7DR

SINGLE SURVEY

Single Survey

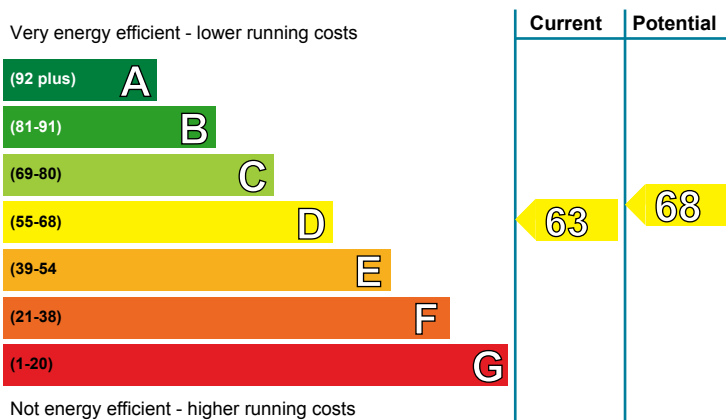
Energy Efficiency Rating

This graph shows the current efficiency of your home, taking into account both energy efficiency and fuel costs. The higher this rating, the lower your fuel bills are likely to be.

Your current rating is **band D (63)**. The average rating for EPCs in Scotland is **band D (61)**.

The potential rating shows the effect of undertaking all of the improvement measures listed within your recommendations report.

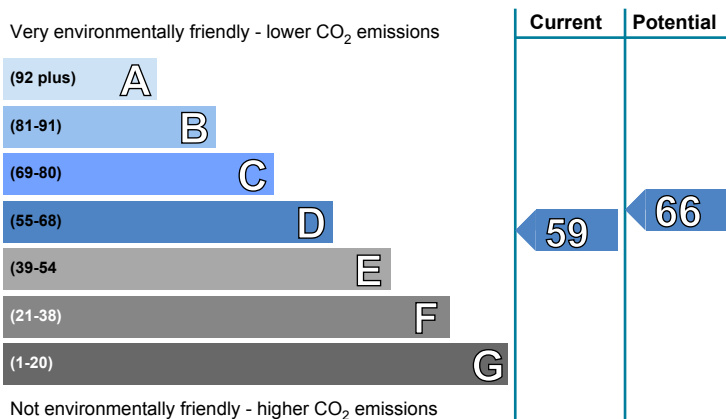
Environmental Impact (CO₂) Rating

This graph shows the effect of your home on the environment in terms of carbon dioxide (CO₂) emissions. The higher the rating, the less impact it has on the environment.
