Home Report

North Warrackston
Farmhouse

Single Survey and Mortgage Valuation Report

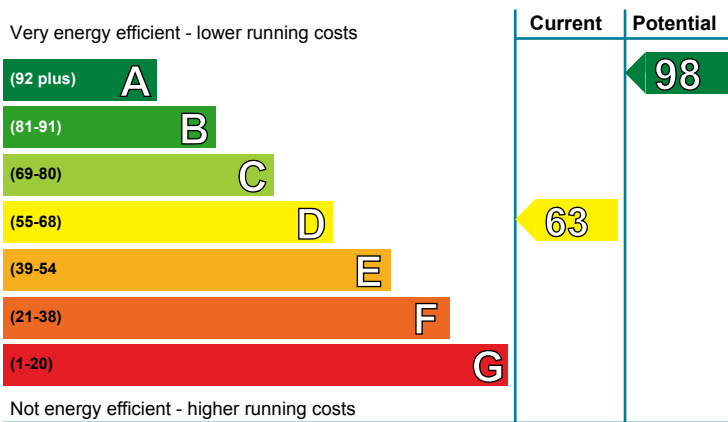
Energy Efficiency Rating

This graph shows the current efficiency of your home, taking into account both energy efficiency and fuel costs. The higher this rating, the lower your fuel bills are likely to be.

Your current rating is **band D (63)**. The average rating for EPCs in Scotland is **band D (61)**.

The potential rating shows the effect of undertaking all of the improvement measures listed within your recommendations report.
