YOUR ONESURVEY
HOME REPORT

Main door
51 Lawrence Street
Partick
Glasgow, G11 5HD

SINGLE SURVEY

Single Survey

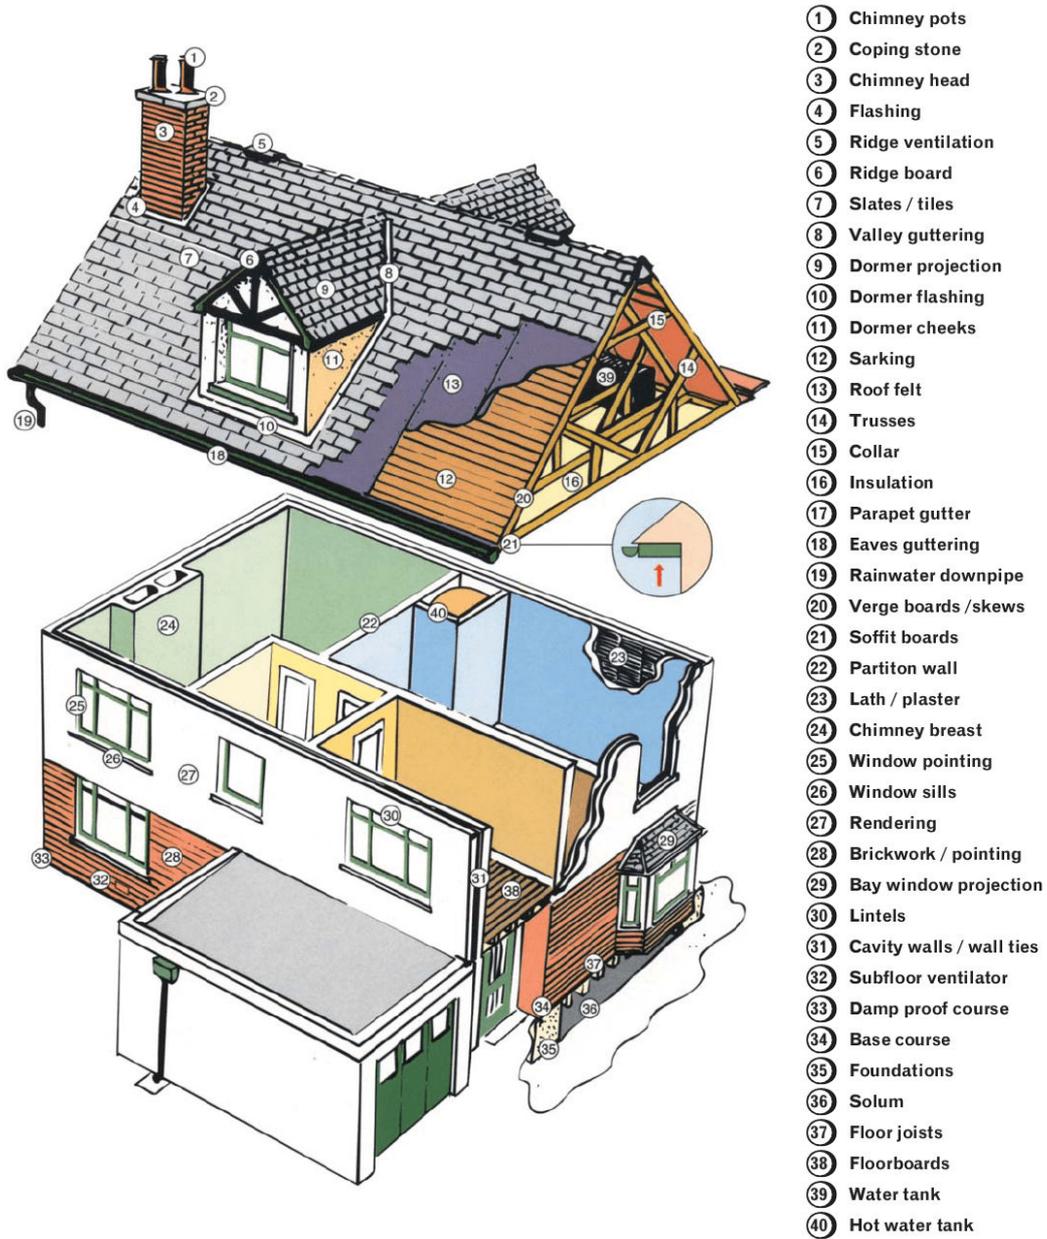
Sectional Diagram showing elements of a typical house

Reference may be made in this report to some or all of the above component parts of the property. This diagram may assist you in locating and understanding these items.

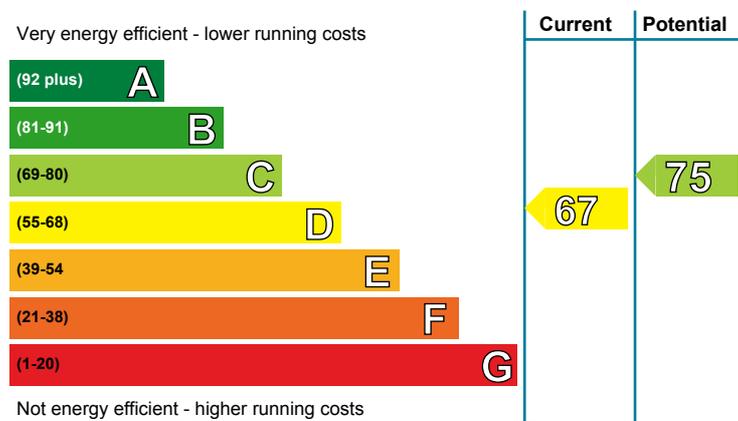
Energy Efficiency Rating

This graph shows the current efficiency of your home, taking into account both energy efficiency and fuel costs. The higher this rating, the lower your fuel bills are likely to be.

Your current rating is **band D (67)**. The average rating for EPCs in Scotland is **band D (61)**.

The potential rating shows the effect of undertaking all of the improvement measures listed within your recommendations report.

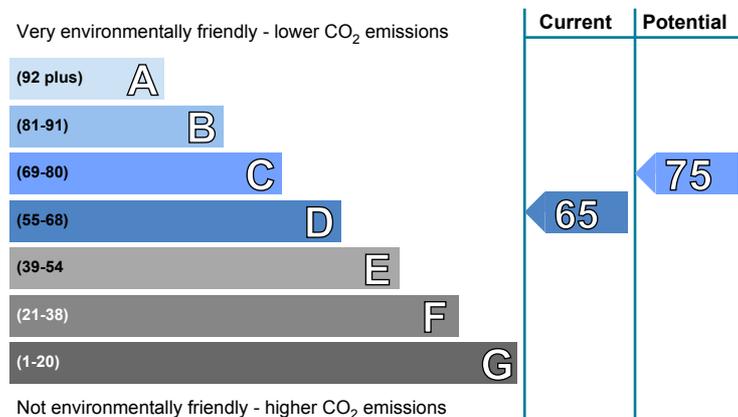
Environmental Impact (CO₂) Rating

This graph shows the effect of your home on the environment in terms of carbon dioxide (CO₂) emissions. The higher the rating, the less impact it has on the environment.
