Home Report

Scottish Single Survey

Property address	Law Of Craigo Farmhouse Craigo Montrose DD10 9LD
-------------------------	-----------------------------------------------------------

Prepared by	Shepherd Chartered Surveyors
--------------------	------------------------------

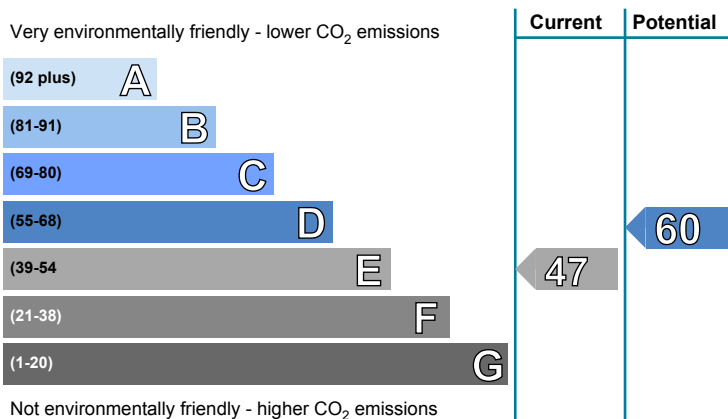
Environmental Impact (CO₂) Rating

This graph shows the effect of your home on the environment in terms of carbon dioxide (CO₂) emissions. The higher the rating, the less impact it has on the environment.
