5 Bairns Ford Avenue,
FALKIRK,
FK2 7LY

Home Report

Single Survey

Property Address	5 Bairns Ford Avenue, FALKIRK, FK2 7LY
Reference	1645483
Customer Name	Lois Hale
Date of Inspection	26th June 2026
Surveyor's name, qualifications and office	Steven Leith BSc (Hons) MRICS DM Hall LLP Chartered Surveyors Unit 6A, The Courtyard Callendar Business Park Falkirk FK1 1XR Tel: 01324 628321 email: centralresidential@dmhall.co.uk
Prepared By	DM Hall LLP

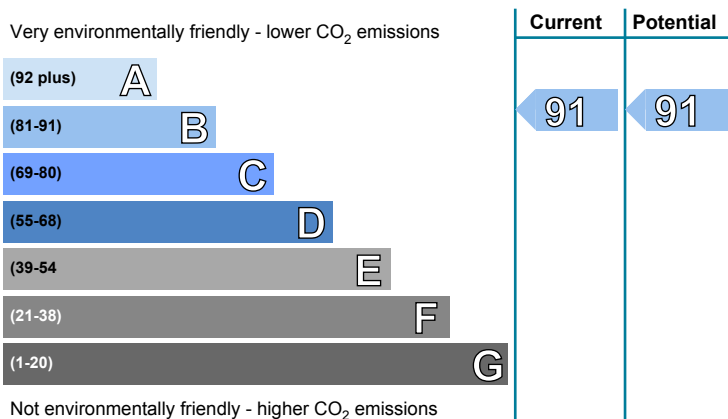
Environmental Impact (CO₂) Rating

This graph shows the effect of your home on the environment in terms of carbon dioxide (CO₂) emissions. The higher the rating, the less impact it has on the environment.
