# Home Report

18 Robertson Way, Nether Dallachy  
Spey Bay Morayshire IV32 7PZ

# Single Survey

<b>Property Address</b>	18 Robertson Way, Nether Dallachy Morayshire IV32 7PZ
<b>Customer</b>	Mrs Susan Lovell-Ulke
<b>Prepared by</b>	Graham + Sibbald Property Consultants Limited
<b>Date of Inspection</b>	28/01/2026

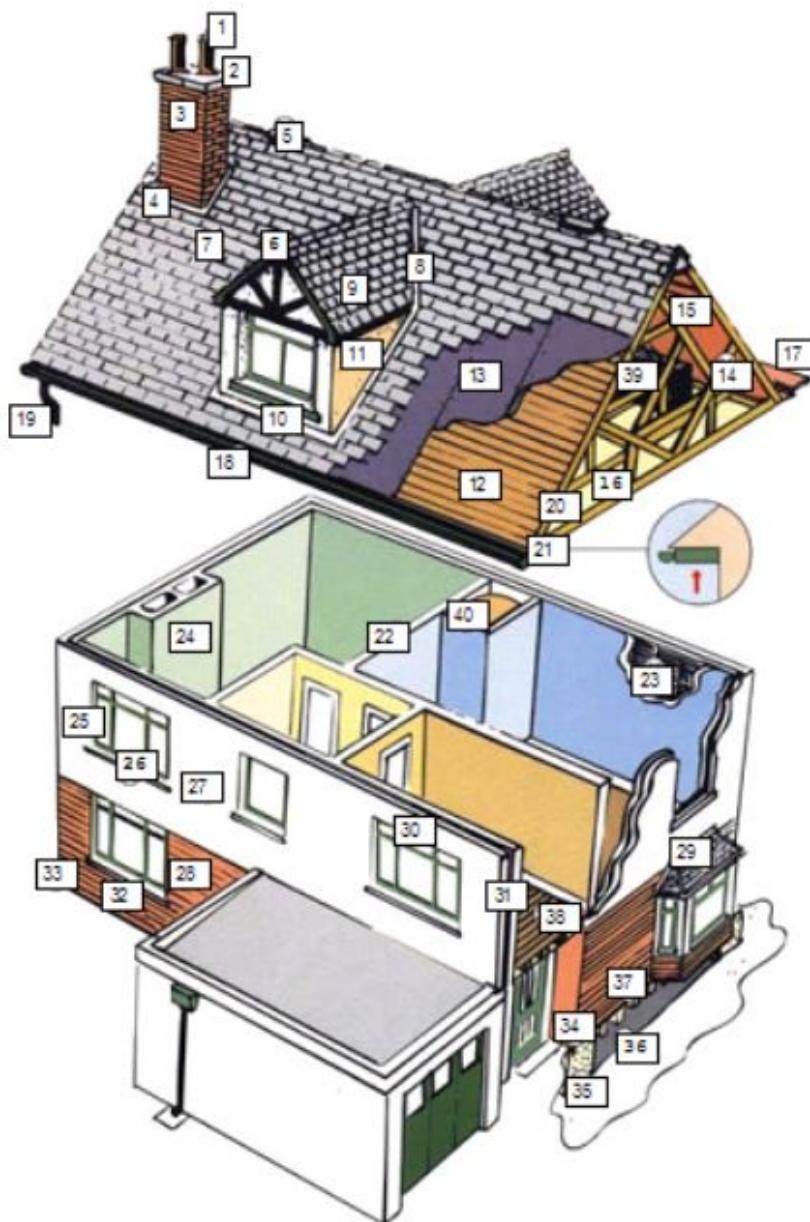
## Sectional diagram showing elements of a typical house

1	Chimney pots
2	Coping stone
3	Chimney head
4	Flashing
5	Ridge ventilation
6	Ridge board
7	Slates / tiles
8	Valley guttering
9	Dormer projection
10	Dormer flashing
11	Dormer cheeks
12	Sarking
13	Roof felt
14	Trusses
15	Collar
16	Insulation
17	Parapet gutter
18	Eaves guttering
19	Rainwater downpipe
20	Verge boards / skews
21	Soffit boards
22	Partition wall
23	Lath / plaster
24	Chimney breast
25	Window pointing
26	Window sills
27	Rendering
28	Brickwork / pointing
29	Bay window projection
30	Lintels
31	Cavity walls / wall ties
32	Subfloor ventilator
33	Damp proof course
34	Base course
35	Foundations
36	Solum
37	Floor joists
38	Floorboards
39	Water tank
40	Hot water tank

Reference may be made in this report to some or all of the above component parts of the property. This diagram may assist you in locating and understanding these items.

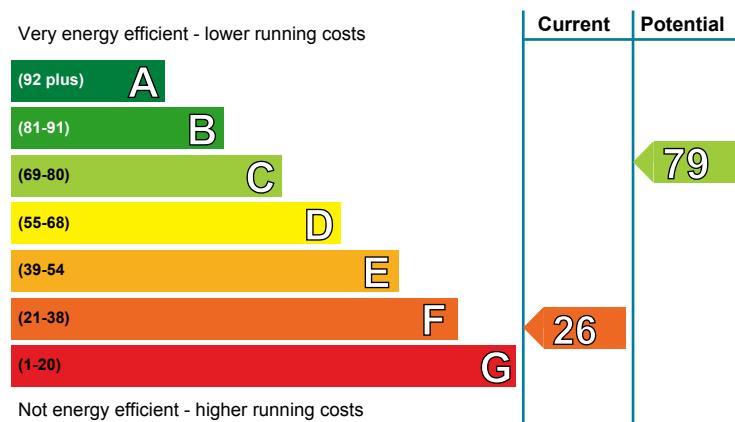
## Energy Efficiency Rating

This graph shows the current efficiency of your home, taking into account both energy efficiency and fuel costs. The higher this rating, the lower your fuel bills are likely to be.

Your current rating is **band F (26)**. The average rating for EPCs in Scotland is **band D (61)**.

The potential rating shows the effect of undertaking all of the improvement measures listed within your recommendations report.

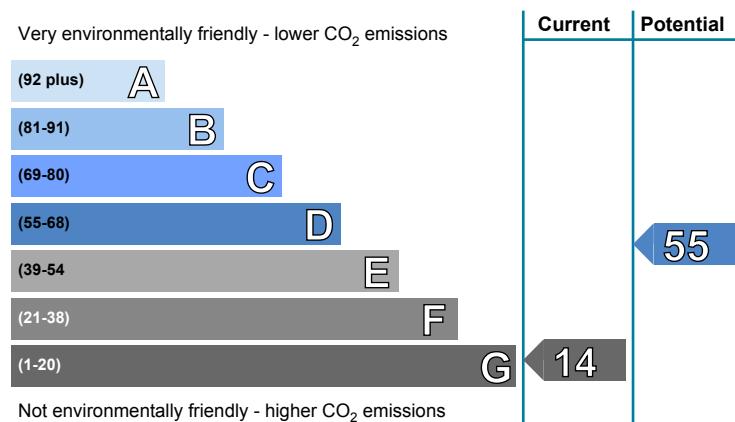
## Environmental Impact (CO<sub>2</sub>) Rating

This graph shows the effect of your home on the environment in terms of carbon dioxide (CO<sub>2</sub>) emissions. The higher the rating, the less impact it has on the environment.
