# Home Report

# Scottish Single Survey

survey report on:

| Property address | Waverley<br>4 Hill Street<br>Dumfries<br>DG2 7AQ |

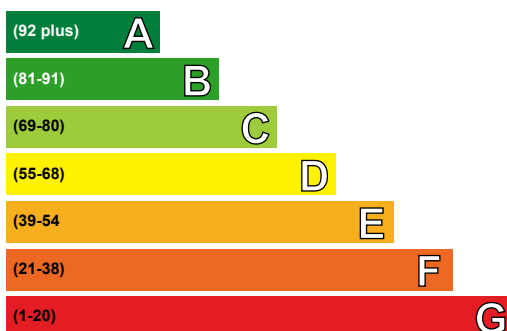
Very energy efficient - lower running costs

Not energy efficient - higher running costs

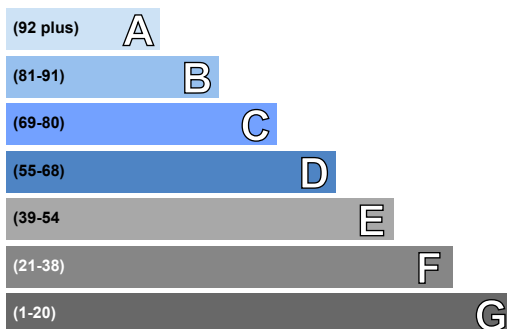
Very environmentally friendly - lower CO<sub>2</sub> emissions

Not environmentally friendly - higher CO<sub>2</sub> emissions
