Home Report

Single Survey

Property address	30 Marine Parade Dundee DD1 3BN
Customer	Mr Martin Bogle
Customer address	30 Marine Parade Dundee DD1 3BN
Prepared by	Shepherd Chartered Surveyors
Date of inspection	05/02/2026

PART 1 - GENERAL

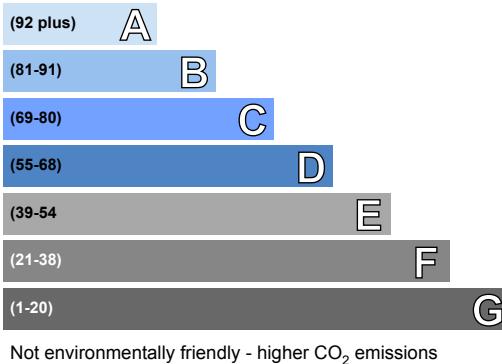
Very environmentally friendly - lower CO₂ emissions

Current

Potential
