Home Report

7 School Road
Wellbank Dundee DD5 3PL

Single Survey

Property Address	7 School Road Wellbank Dundee DD5 3PL
Customer	Liam & Kirsty Crawford
Prepared by	Graham + Sibbald Property Consultants Limited
Date of Inspection	08/04/2026

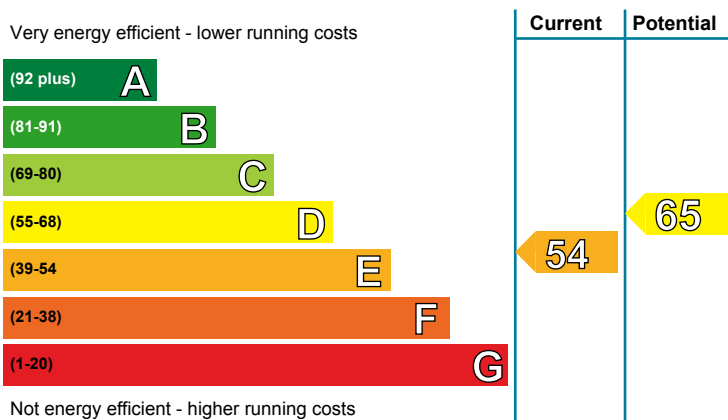
Energy Efficiency Rating

This graph shows the current efficiency of your home, taking into account both energy efficiency and fuel costs. The higher this rating, the lower your fuel bills are likely to be.

Your current rating is **band E (54)**. The average rating for EPCs in Scotland is **band D (61)**.

The potential rating shows the effect of undertaking all of the improvement measures listed within your recommendations report.
